Trinity Groves Phase II

TRINITY GROVES – TIF EXHIBIT MAP

TRINITY GROVES – TIF EXHIBITS

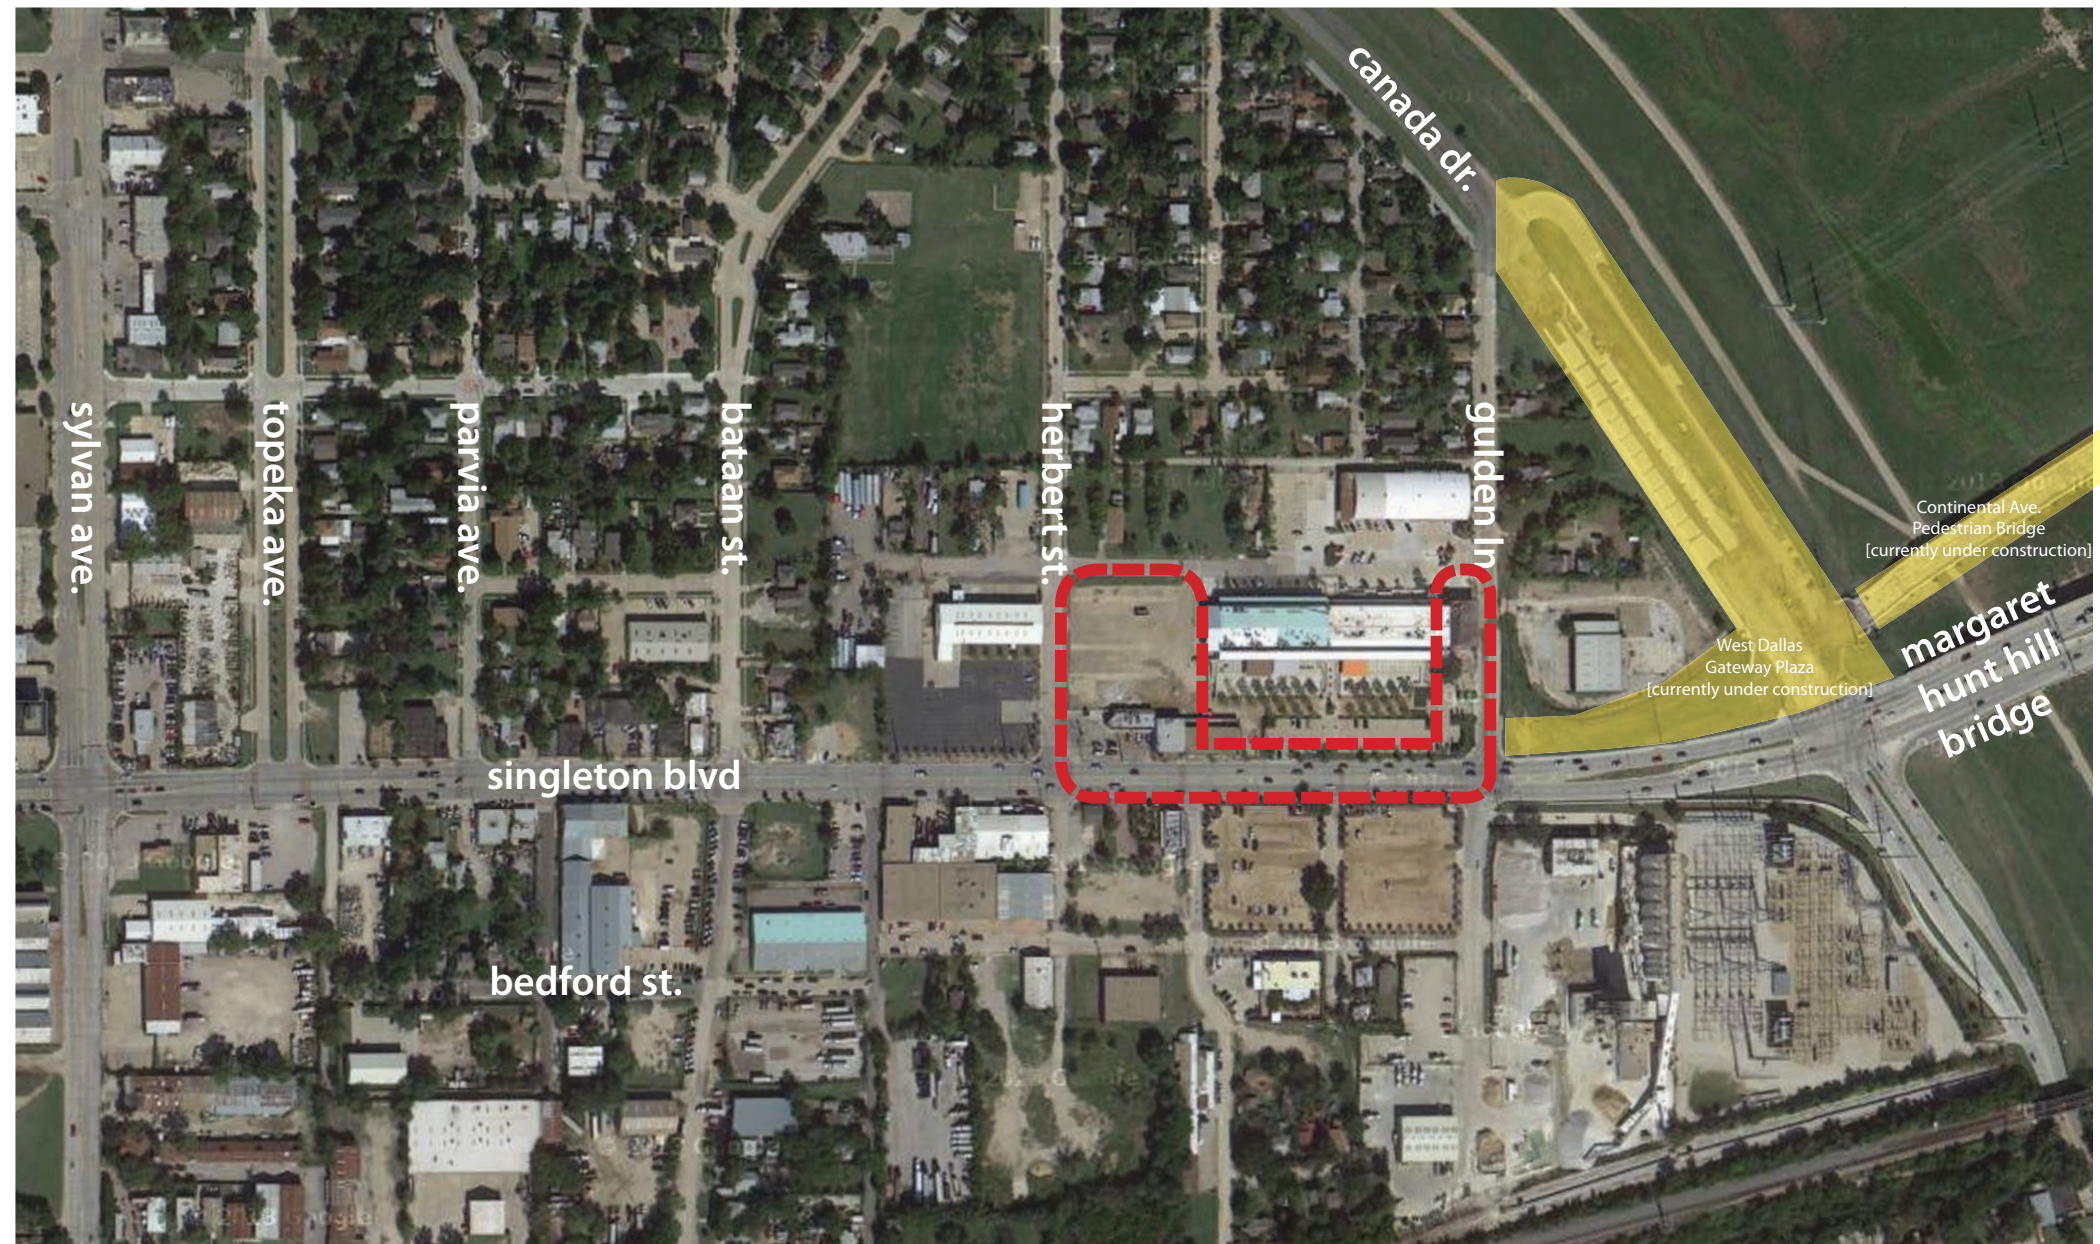
- [1] **Increasing width of sidewalk along Singleton to meet the face of existing buildings and continuing the sidewalk width along Singleton to the future gateway plaza** - The existing sidewalks along Singleton, while designed with high quality materials and streetscape elements, are often narrow and do not promote walkability. Introducing additional sidewalk width along Singleton helps to leverage recent improvements while enhancing the walkability of the proposed development.

- [2] **Consider traffic calming measures to slow traffic between Margaret Hunt Hill bridge and Sylvan Avenue that supports the long term vision for the street** - Public realm improvements on Singleton should be coordinated with planned development on southern edge of the street, and with long term transportation plans along the corridor. The design of pedestrian improvements should take into account plans for a planted median, enhanced pedestrian crossings, and additional traffic signaling.

- [3] **Continue streetscape around all four block faces** - Streetscape improvements should be continued on all sides of the site to support the future vision for the neighborhood.

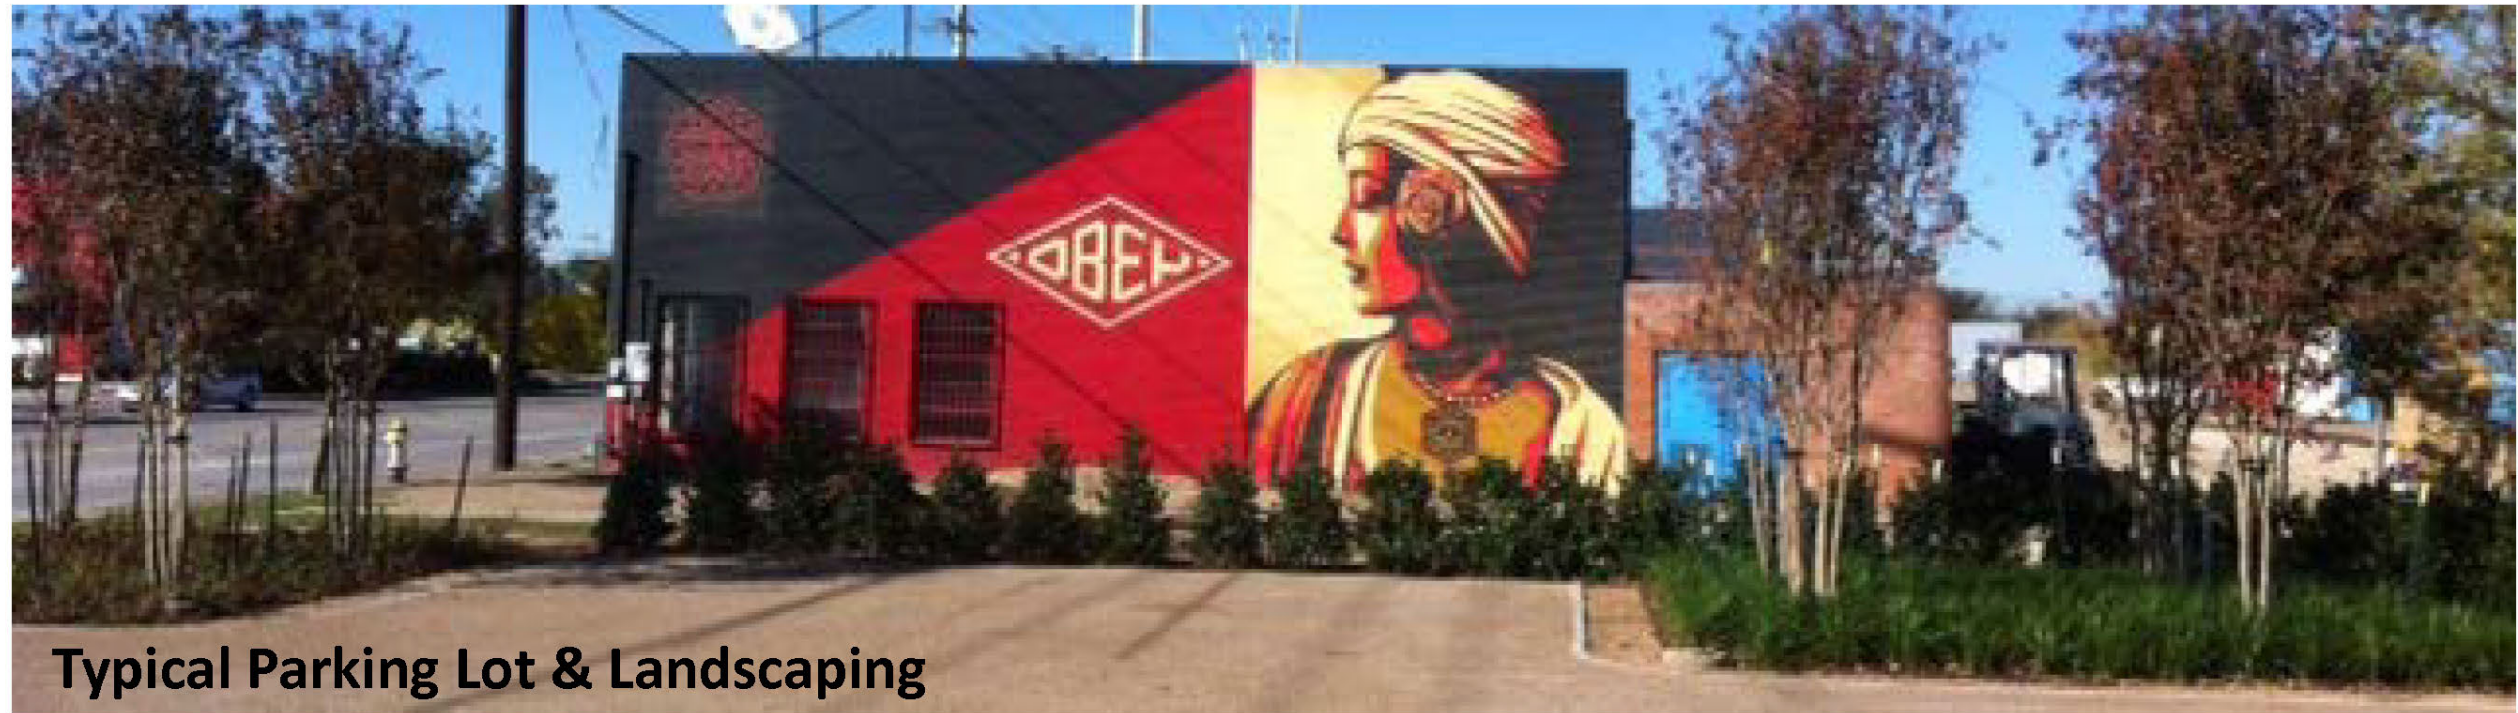
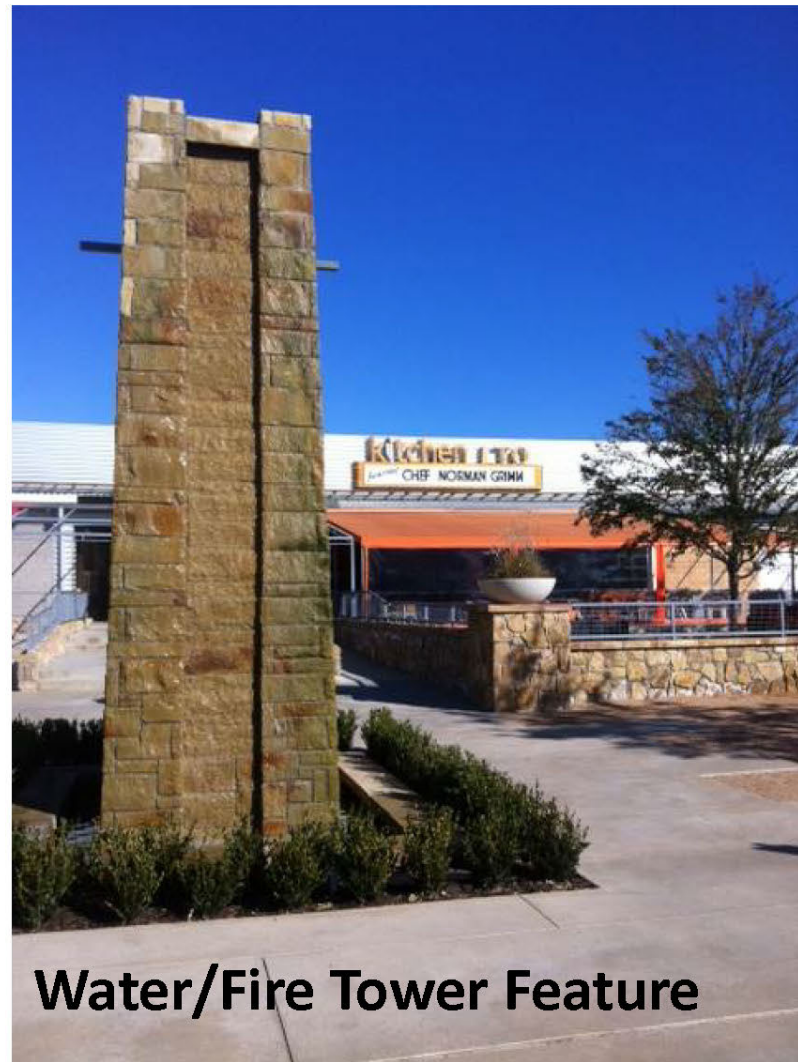
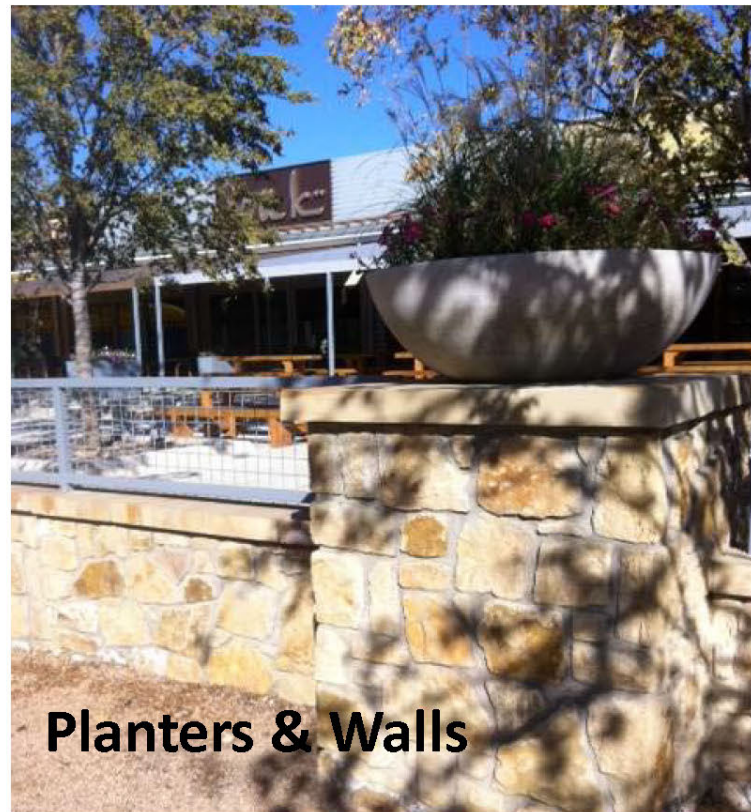
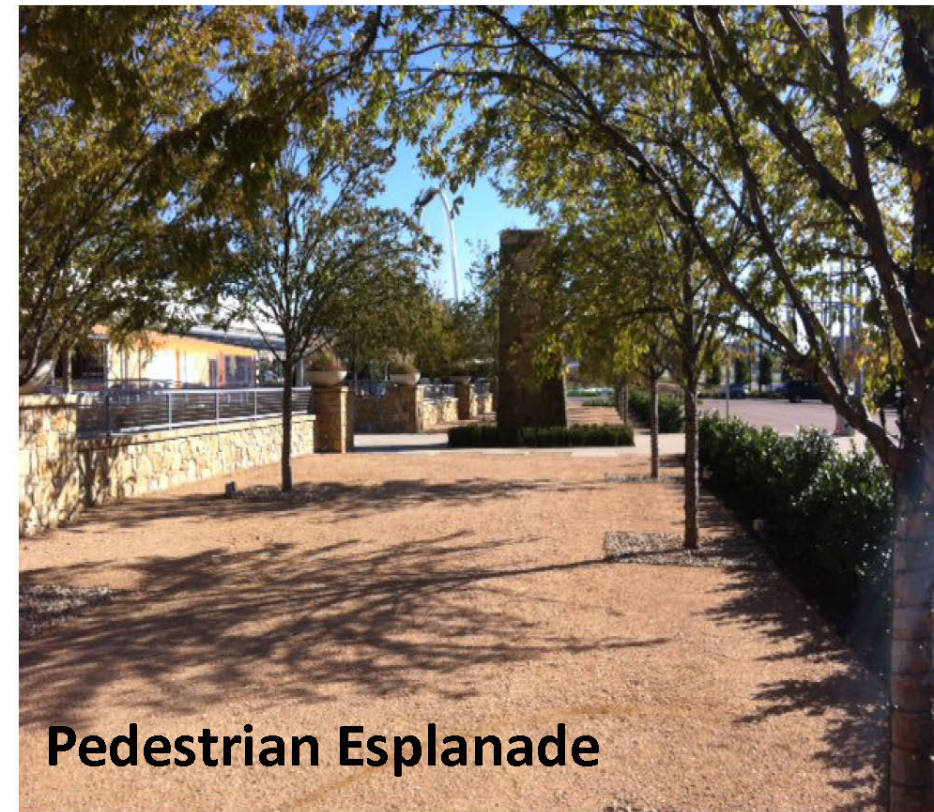
**Recently Completed Improvements
& Existing Context Photos**

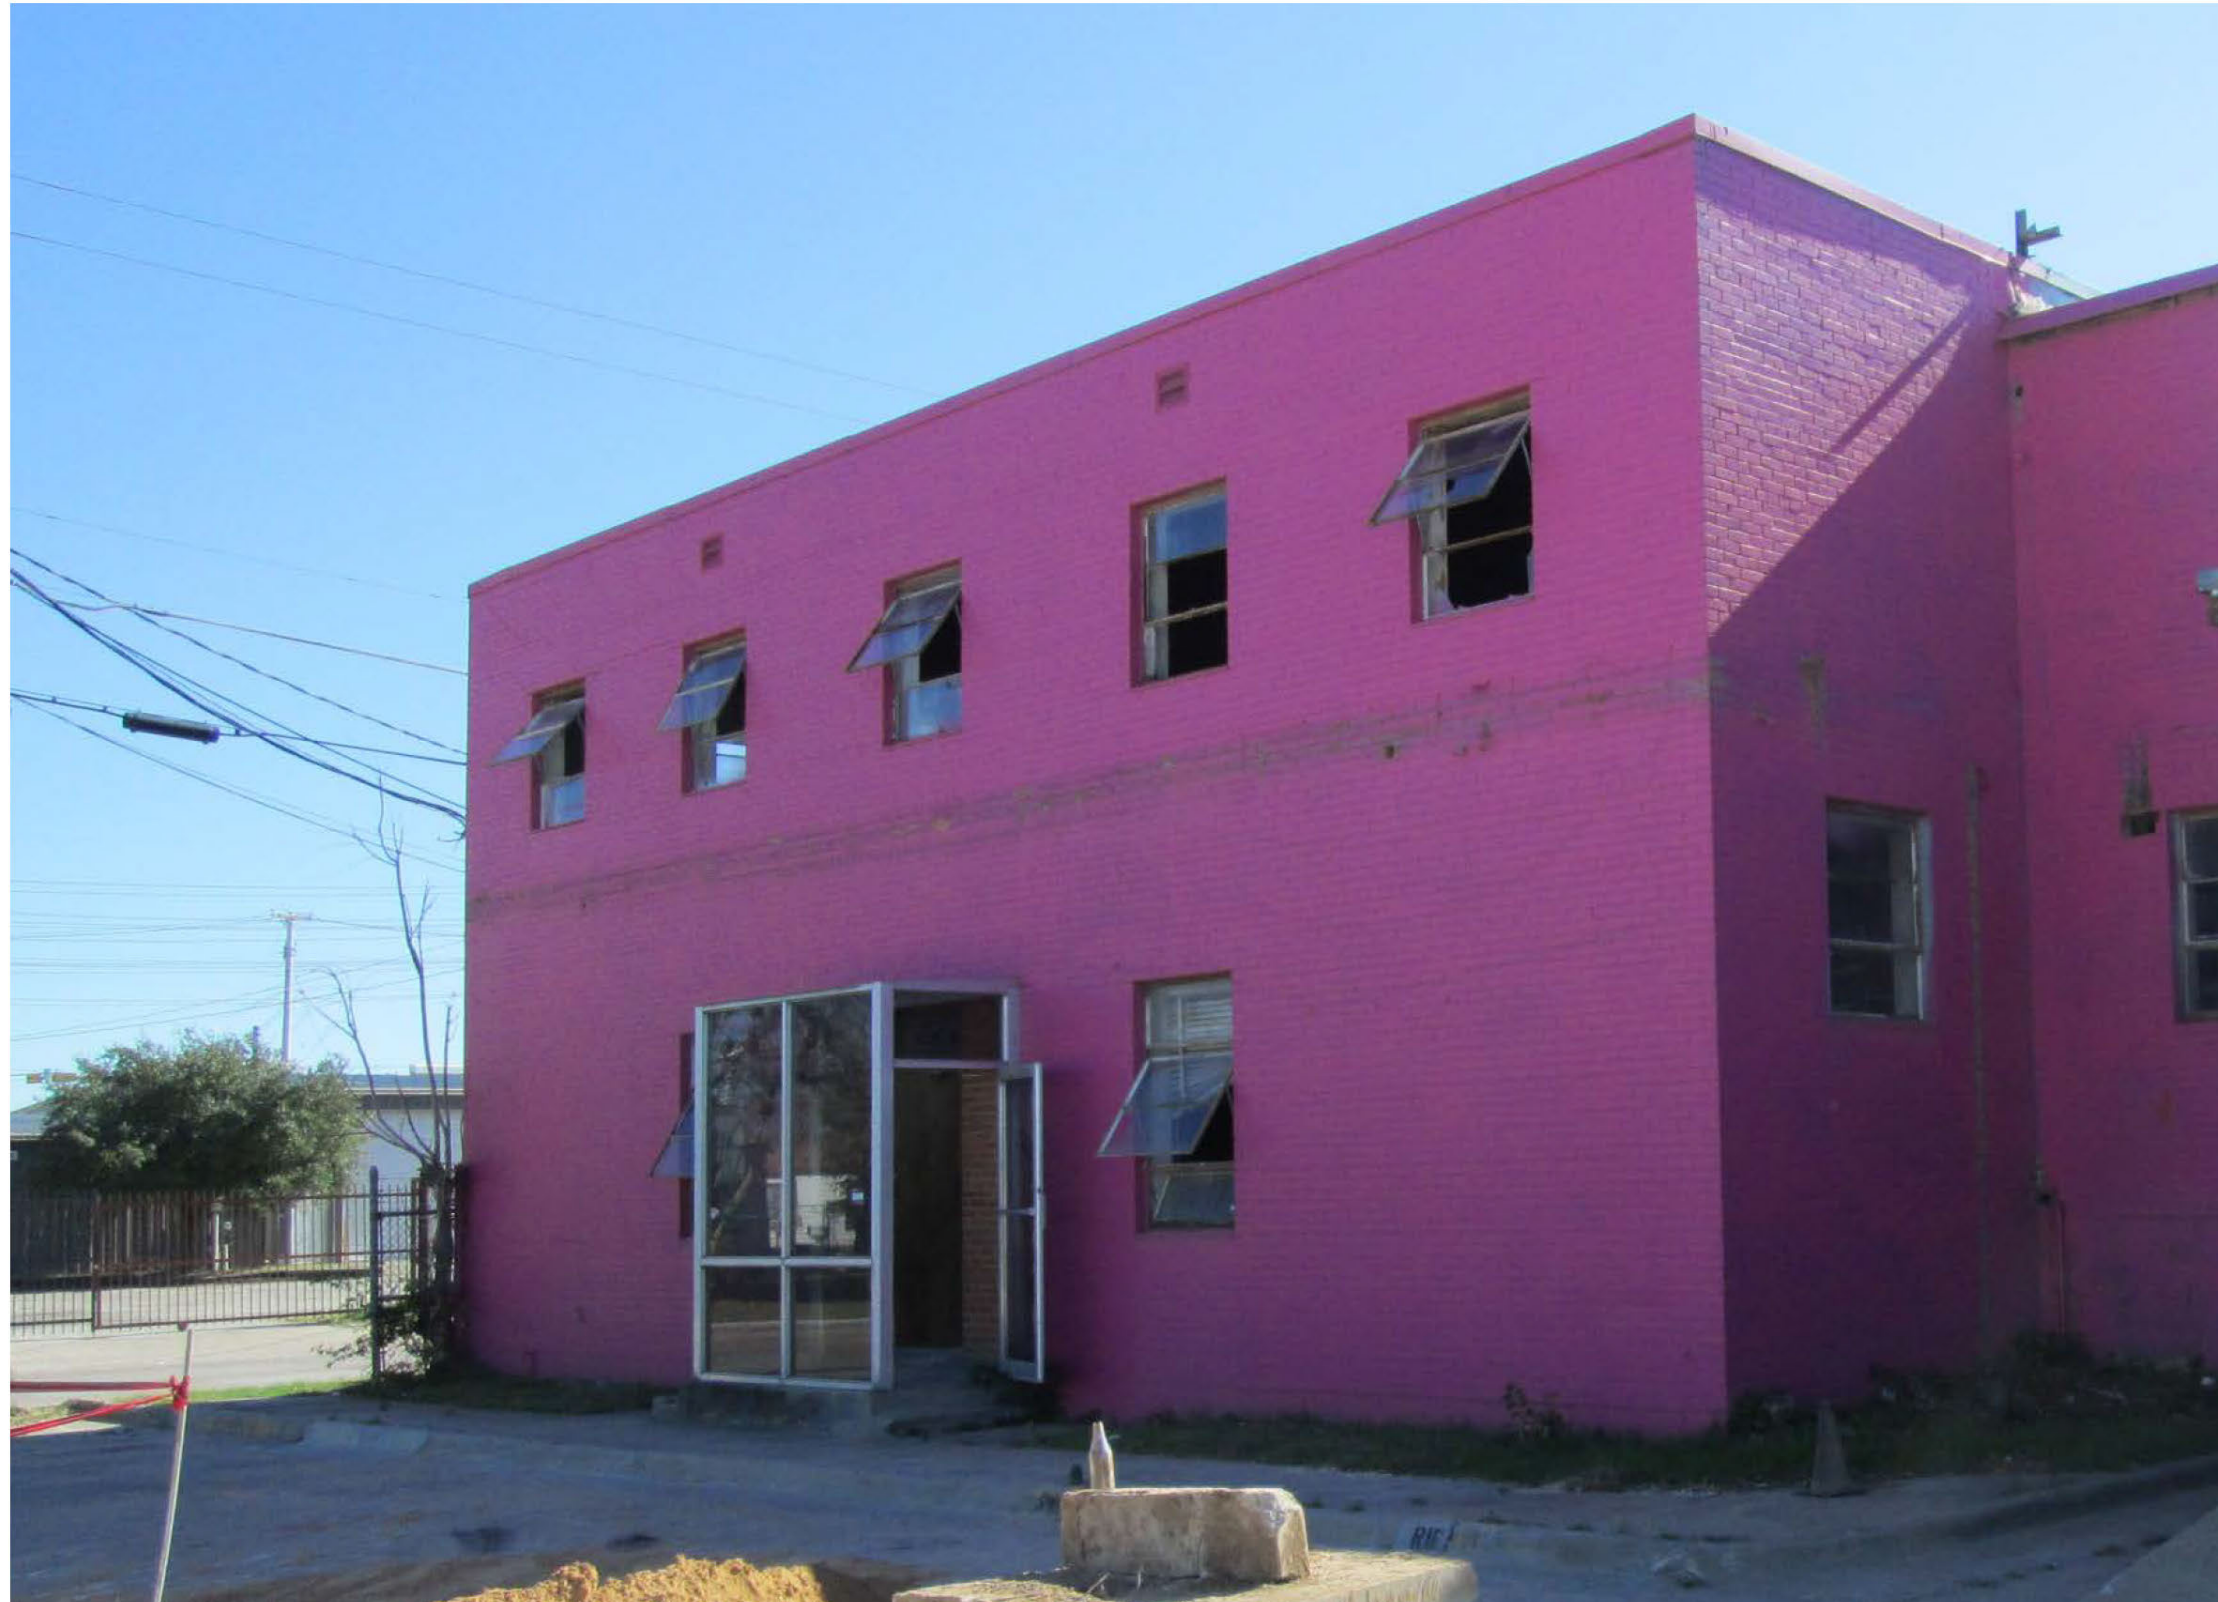
Exhibit **B** - Existing Shell Building (Northside)

New 3 Story Stair/Elevator Addition,
ADA Access, Landscaping &
Exterior Shell Building Improvements
**(PLEASE NOTE: The Current Design has changed.
The stair corner glazing is now oriented to the street
per attached elevations)**

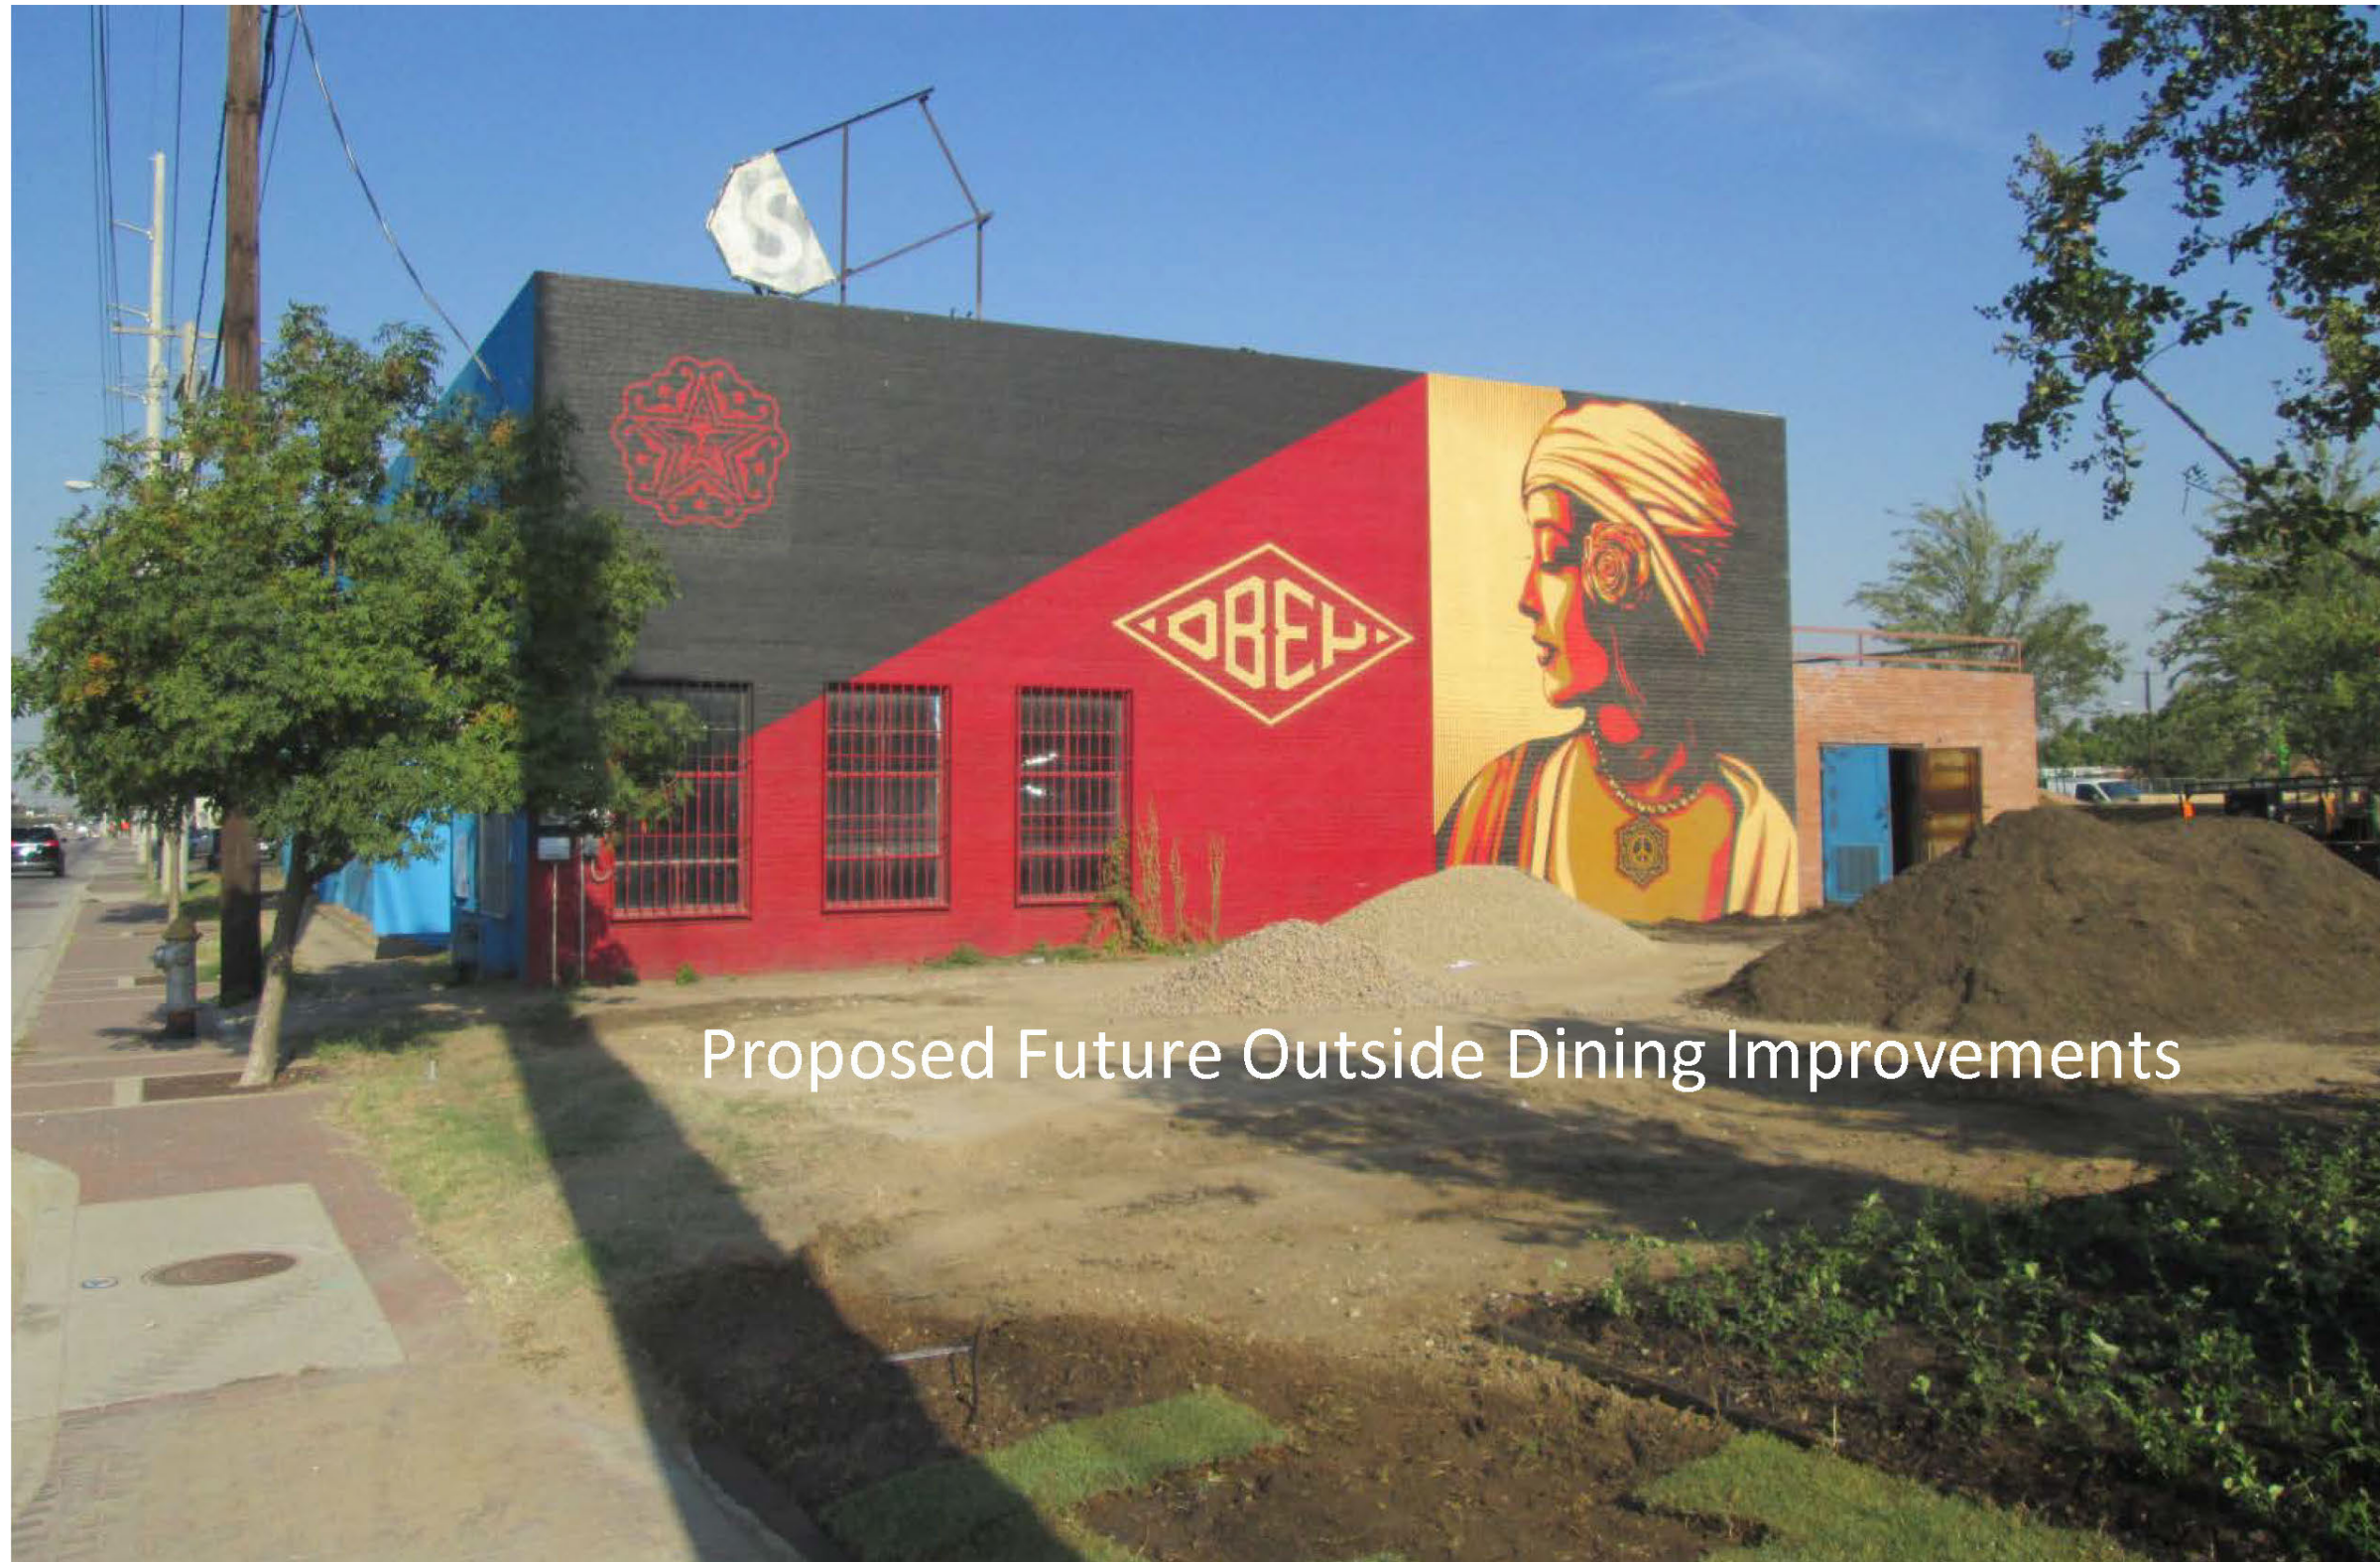
Exhibit D - Existing Shell Building & Landscape(Eastside)

New Shell Bldg. Elevator/ ADA Access,
Site Paving, Landscaping &
Exterior Building Improvements
