EXHIBIT D

PHOTOGRAPHS OF EXISTING STRUCTURES

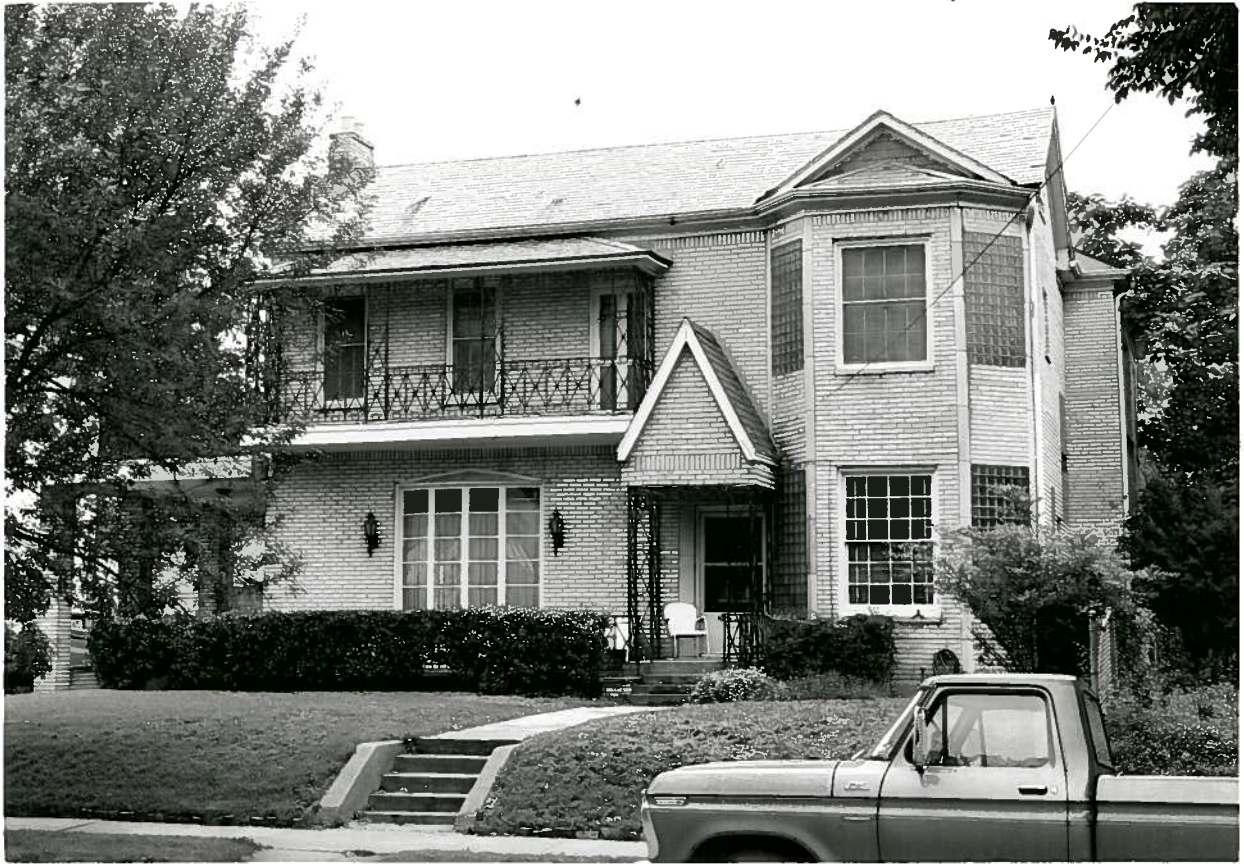
No. 1 - 2508 Thomas

Approx. 1890-95;

Description: Originally Victorian, stripped to frame in 1940's, beige brick, glass block in place of stain glass, 2 story, end chimney, 2nd floor balcony, 12/12, 8/8, 9/9 windows.

Condition: Excellent

Significance: Probably none-altered.

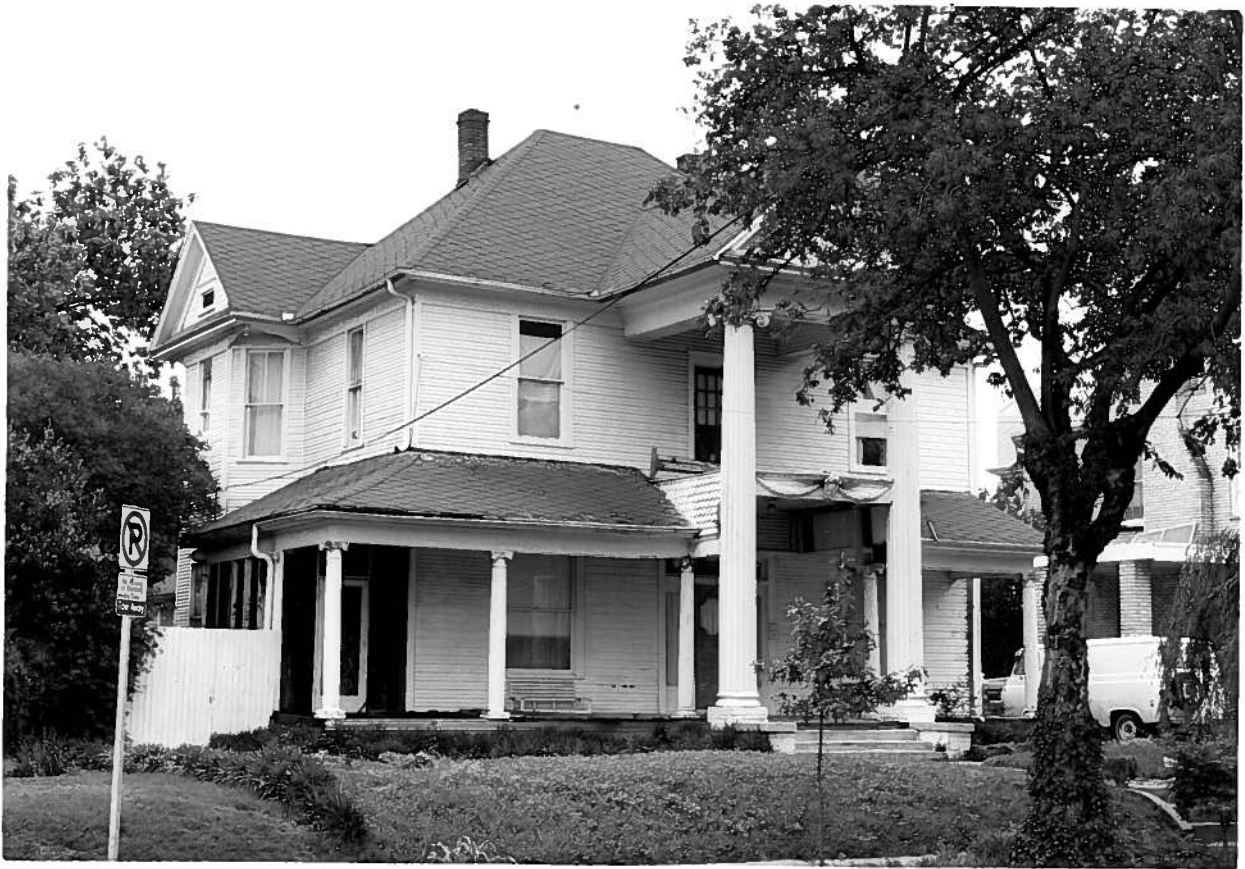
No. 2 - 2512 Thomas

Approx. 1890-95;

Description: Late Victorian, 2 story, main roof-steep hip, intersecting gables, bay pavilions, Ionic porch columns, 2 story Ionic columns at center, fishscale shingles at gable ends, transom side and corner lights, interior chimney, tall 1/1, 2/1 windows, wood porch.

Condition: Excellent.

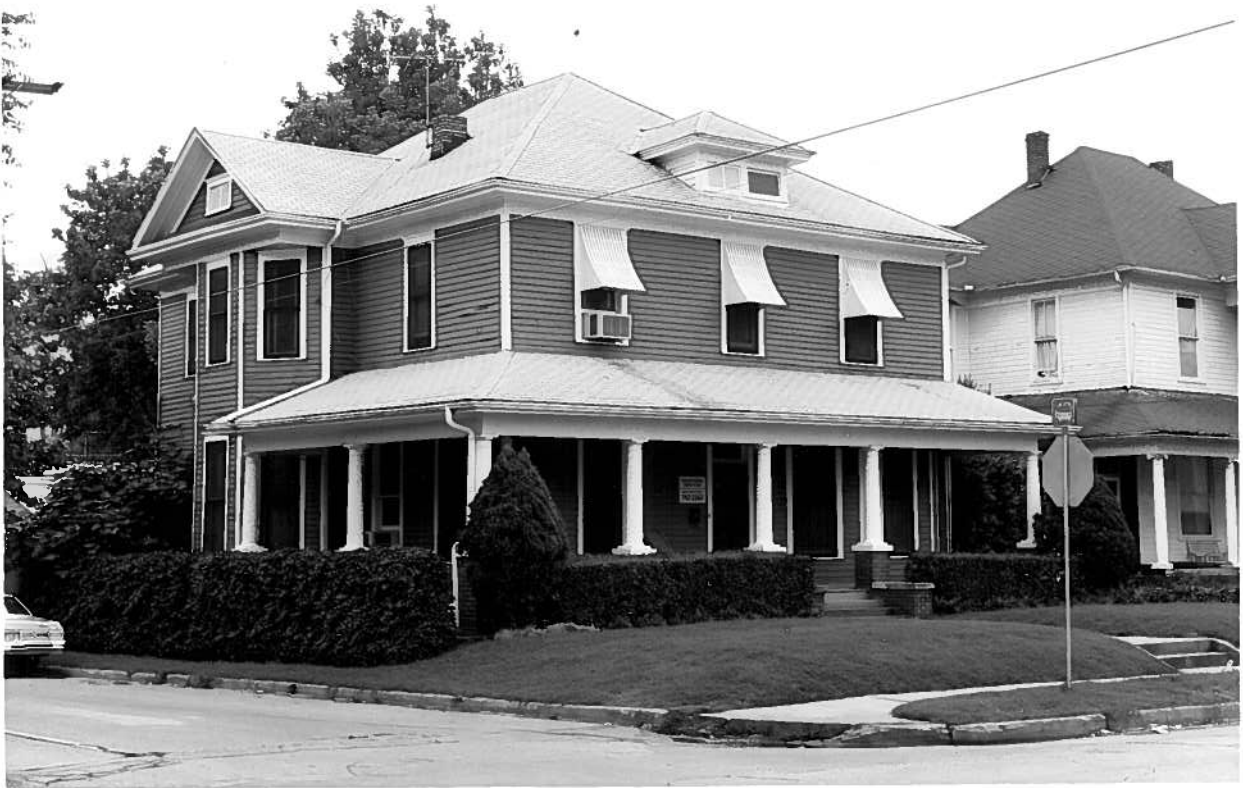
No. 3 - 2516 Thomas

Approx. 1890-1900;

Description: Late Victorian, main hip roof, gable with bay pavilion, 2 story, wrap porch with hip roof and Doric columns on brick piers, hip dormer, interior chimney, transom, tall 1/1 windows with cornice window heads;

Condition: excellent.

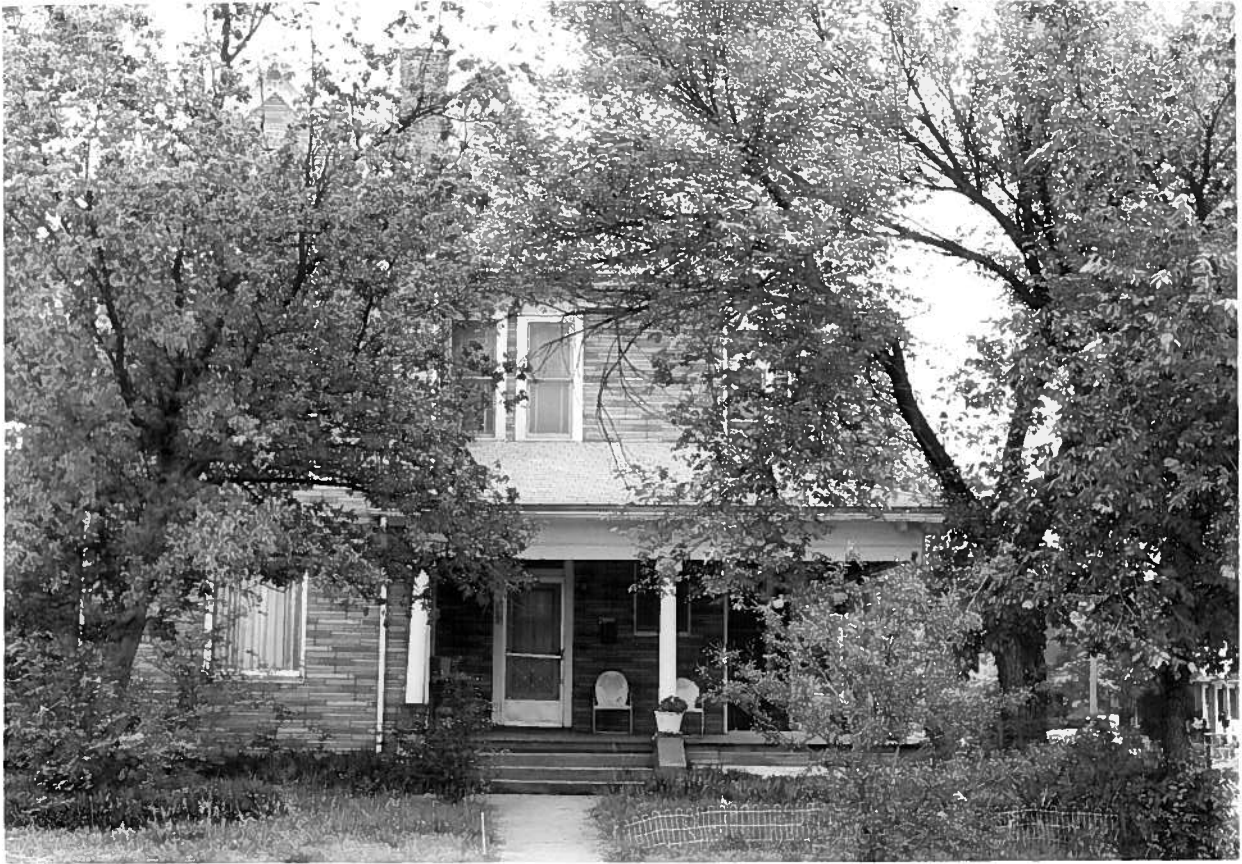
No. 4 - 2600 Thomas

Approx. 1890-1900;

Description: 2 story, tall, narrow 1/1 windows,
Doric style porch columns, covered with siding.

Condition: Good.

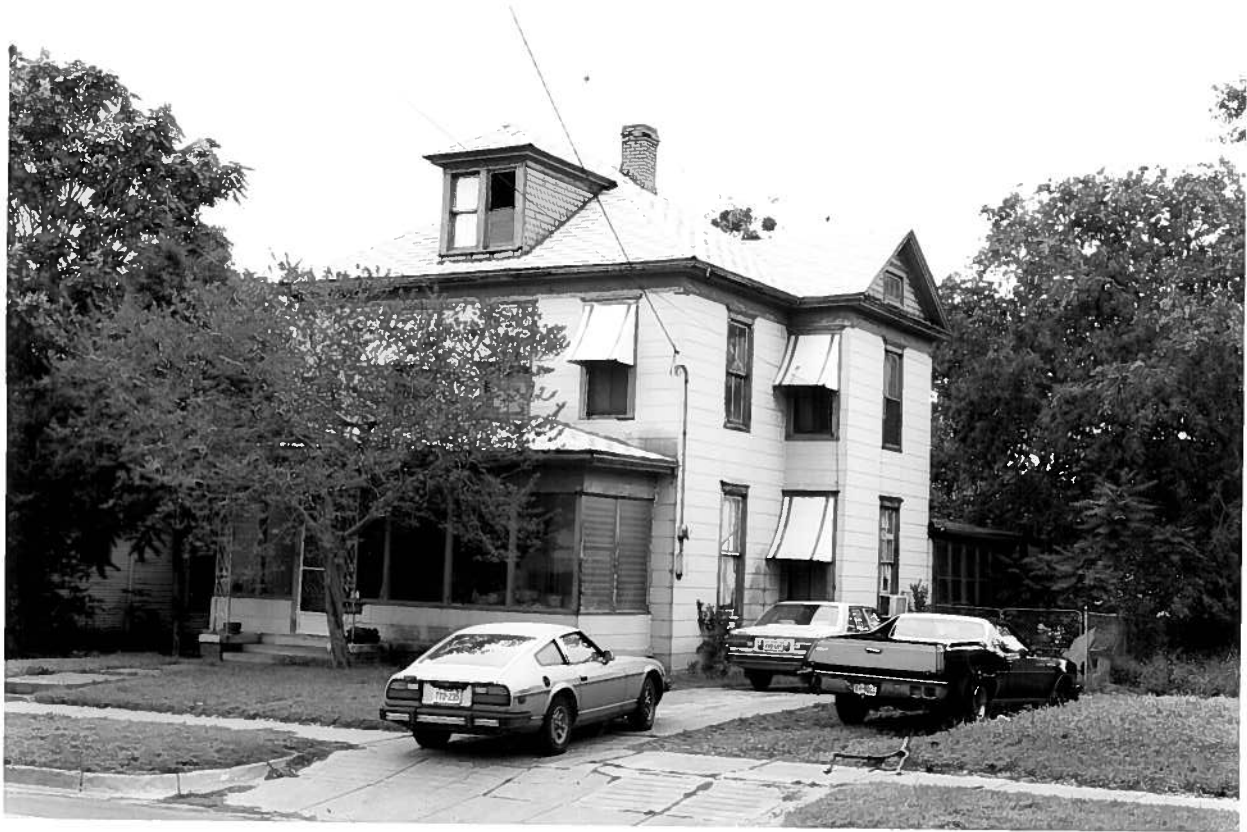
No. 5 - 2612 Thomas

Approx. 1890-1900;

Description: 2 story, Craftsman, 1/1, 2/1 windows, 1/1 paired dormer windows, addn. on front, metal awnings added.

Condition: Good.

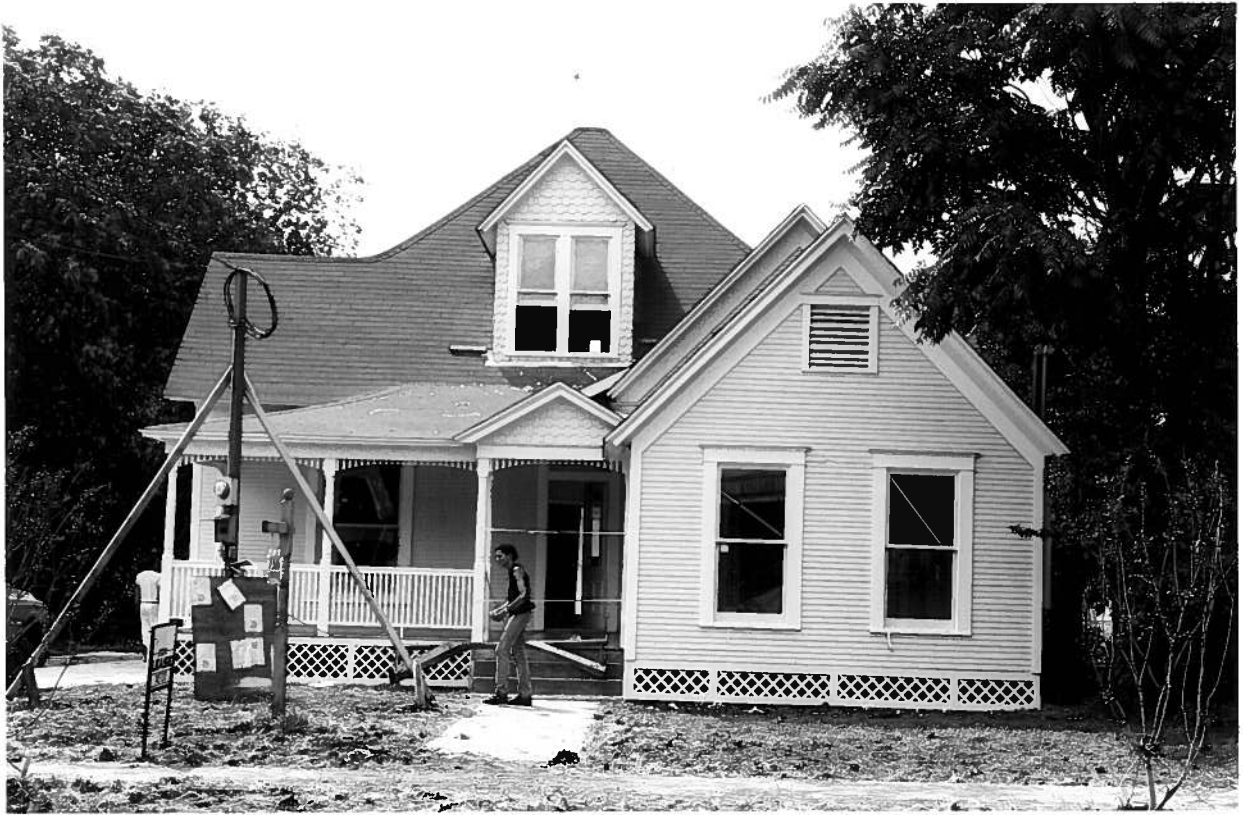
No. 6 - 2616 Thomas

Approx. 1880-90;

Description: Vernacular Victorian, 1- $\frac{1}{2}$ story, wood frame, steep pitched gable roof, 1/1 windows, 1/1 paired dormer windows; turned porch posts.

Condition: Excellent.

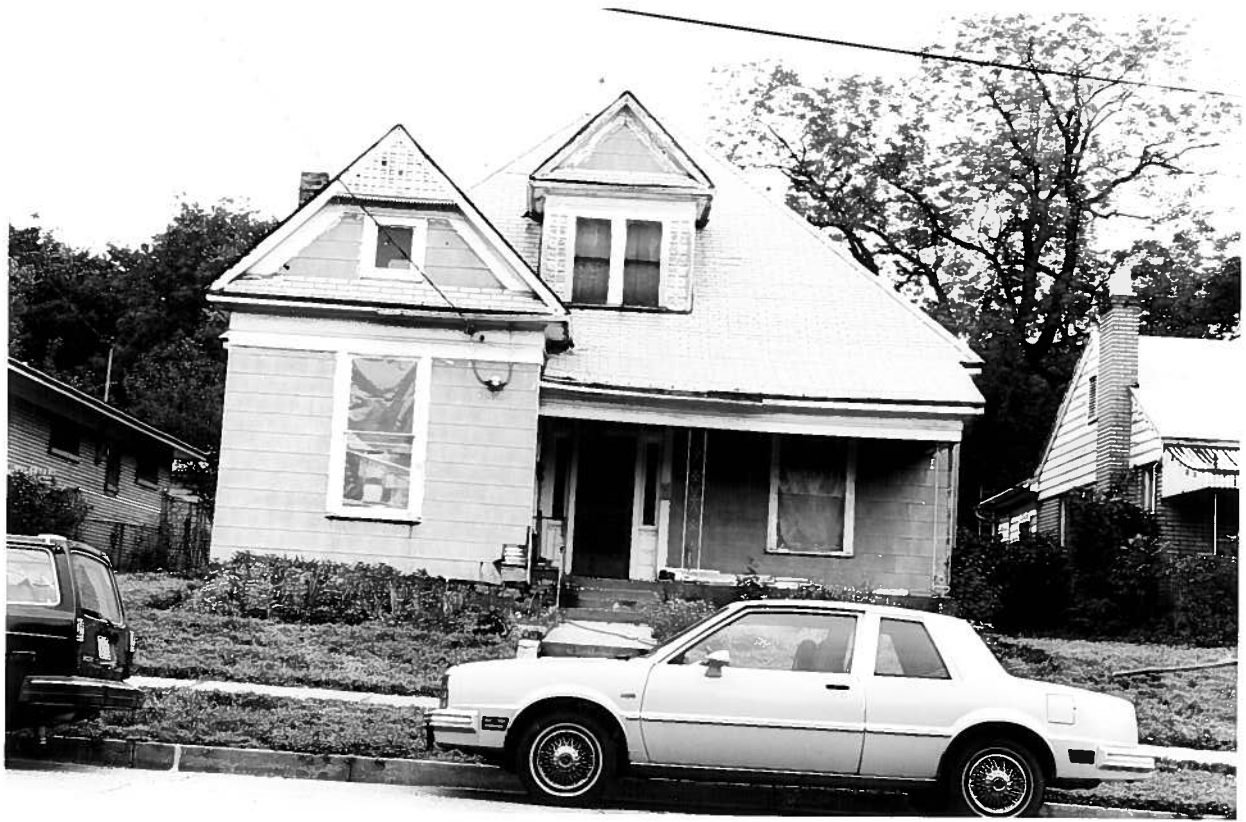
No. 7 - 2613 Thomas

Approx. 1890-1900;

Description: Victorian cottage planbook, steep hip roof with shortridge, intersecting gable, large gable dormer, side chimney, gable end trim, 1/1 windows, wide trim boards.

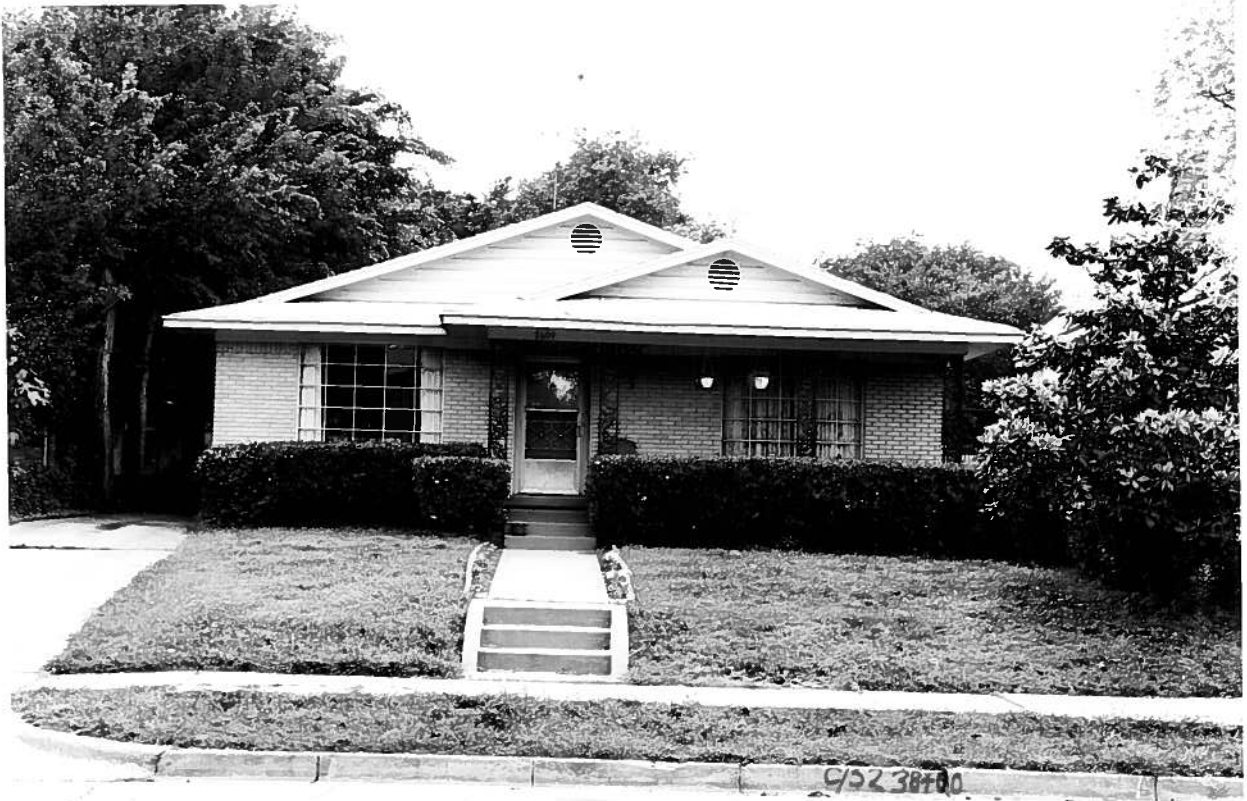
No. 8 - 2609 Thomas

Approx. 1950-60;

Description: shallow gable roof, smaller front gable projection, boxed extended eaves, beige brick, grillwork porch posts, bowed large 25 pane front windows.

Condition: excellent.

Significance: None - too new.

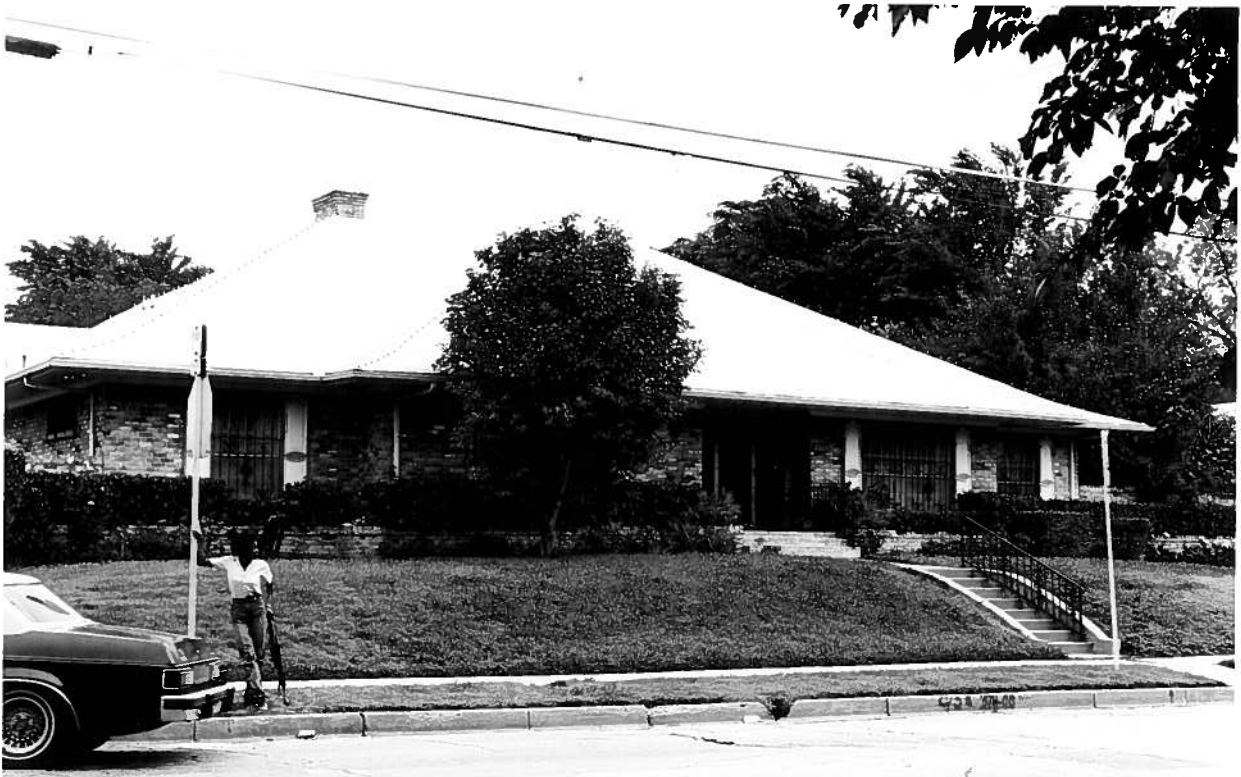
No. 9 - 2605 Thomas

Approx. 1950-60;

Description: layered hip roof, interior chimney, large picture windows, medium color brick.

Condition: Excellent.

Significance: None - too new.

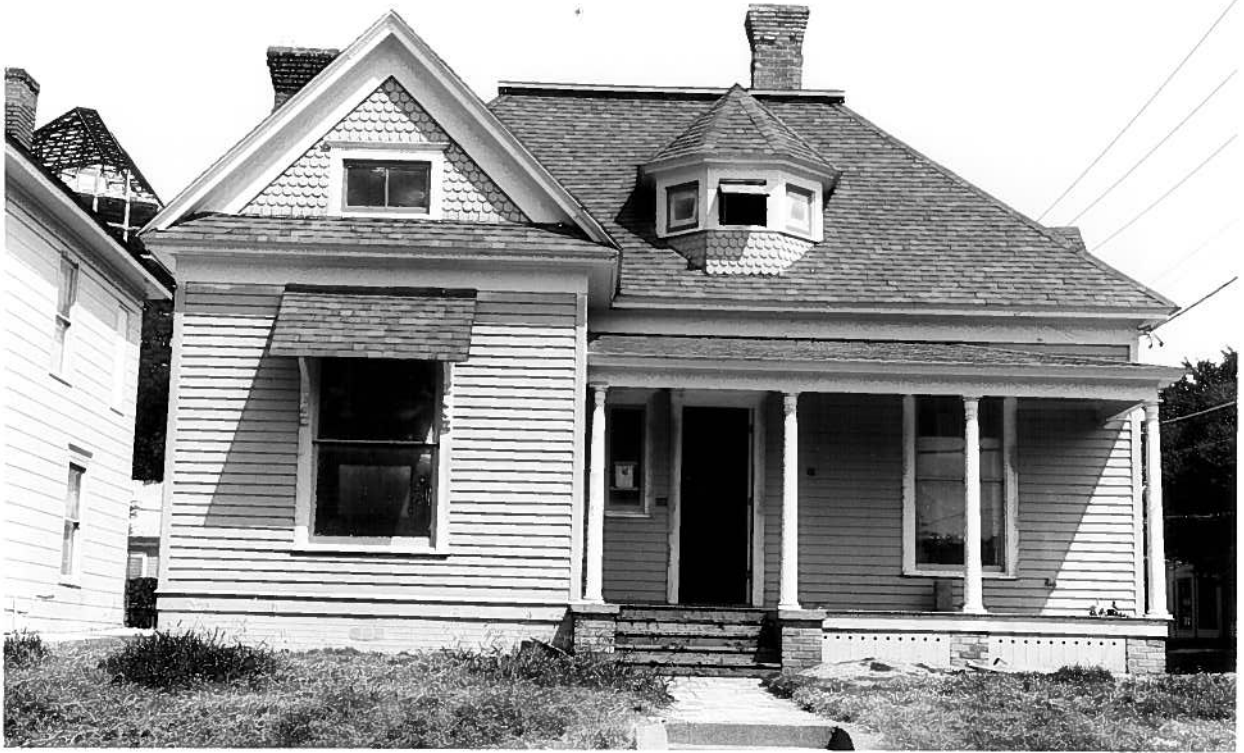
No. 10 - 2519 Thomas

Approx. 1890-1900;

Description: Victorian cottage planbook, main hip roof with large intersecting gables front and side, shed porch roof with classical columns, turret dormer, angle turned brackets for front window awning, fishscale shingles in gable ends, 1/1 windows, center and side end chimneys.

Condition: Excellent
