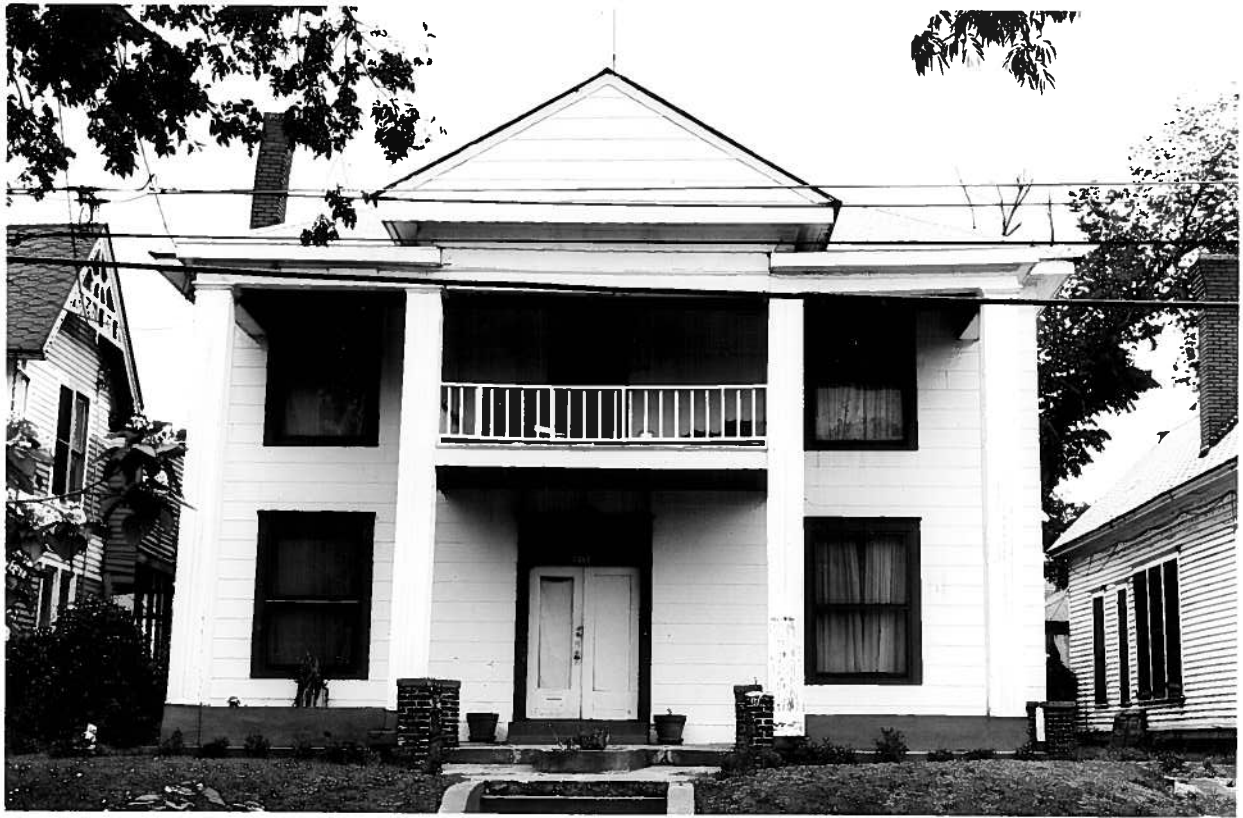
No. 11 - 2517 Thomas

Approx. 1900-10;

Description: Craftsman, 2 story, shallow hip roof with extended box eaves, large pediment centered on front, 4 large 2 story square columns, cornice window heads, wide 1/1 windows, transom over double front door, tall side exterior.

Condition: Good.

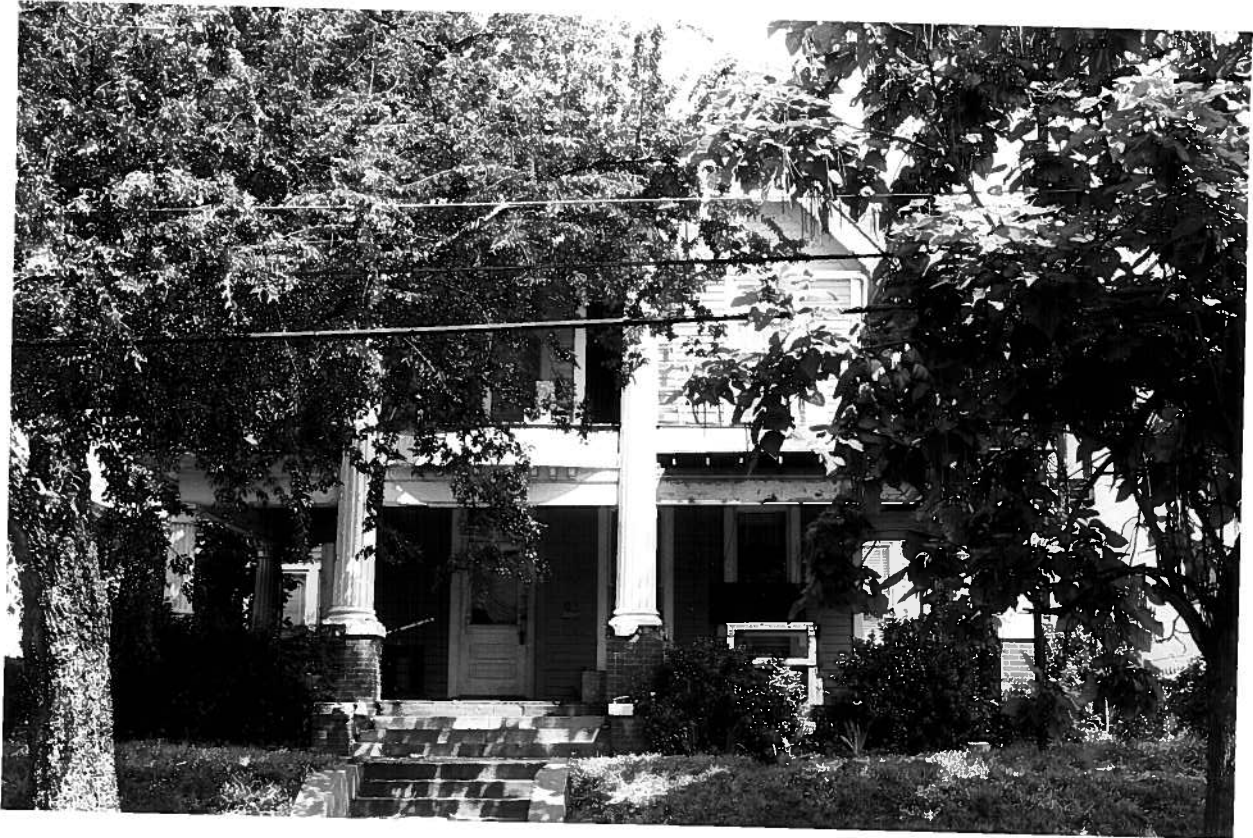
No. 12 - 2513 Thomas

Approx. 1890-95;

Description: Late Victorian, 2 story, intersecting gables, interior chimney, elaborate gable trim and bargeboard, tall 1/1 windows with elaborate cornice window heads, Doric columns with fluted shafts, center 2 columns are 2 stories tall, fishscale shingle string course, brick porch piers, transom.

Condition: Good.

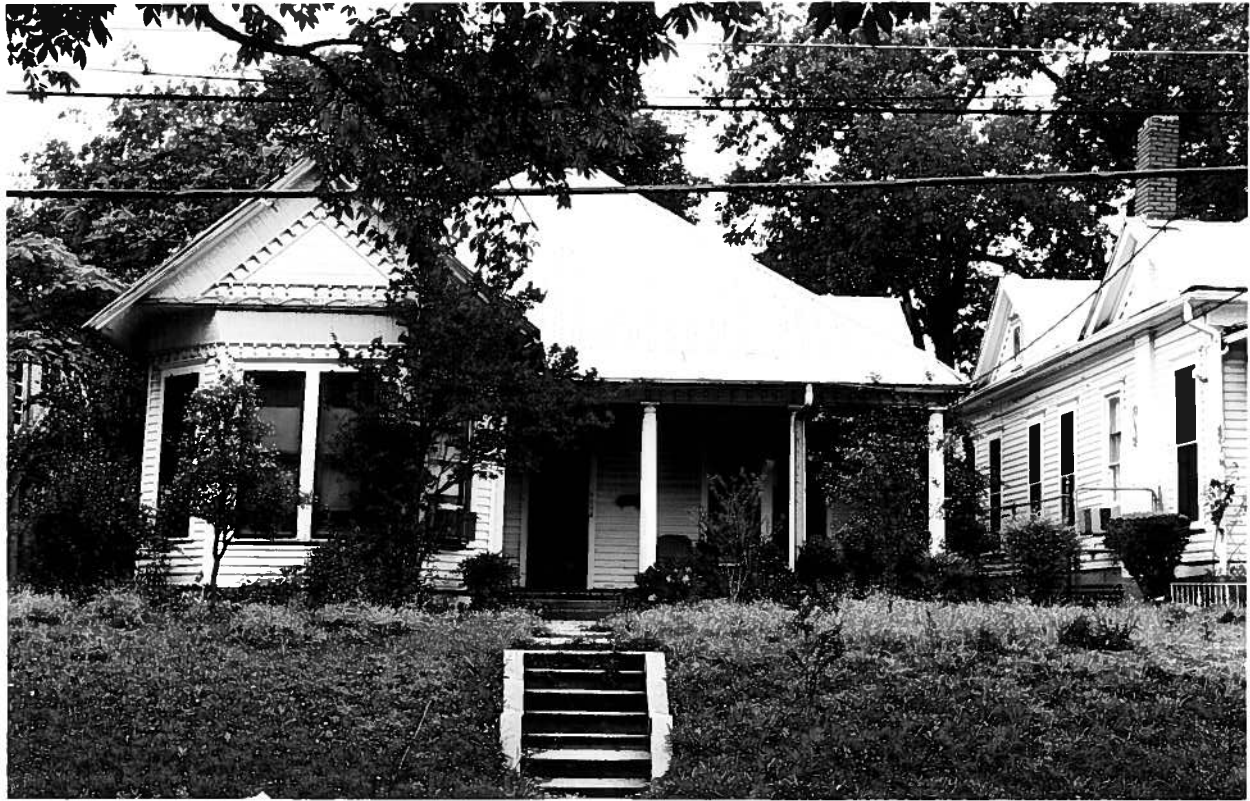
No. 13 - 2509 Thomas

Approx. 1890-95;

Description: Victorian planbook, steep short-ridge pyramid main roof, front and side gable projections, Doric columns, bay under front gable, front gable end highly decorative with angle trim boards and brackets 6" apart all around, 6" spaced brackets around bay and porch cornice, 1/1 windows with cornice window heads.

Condition: Good - maintained.

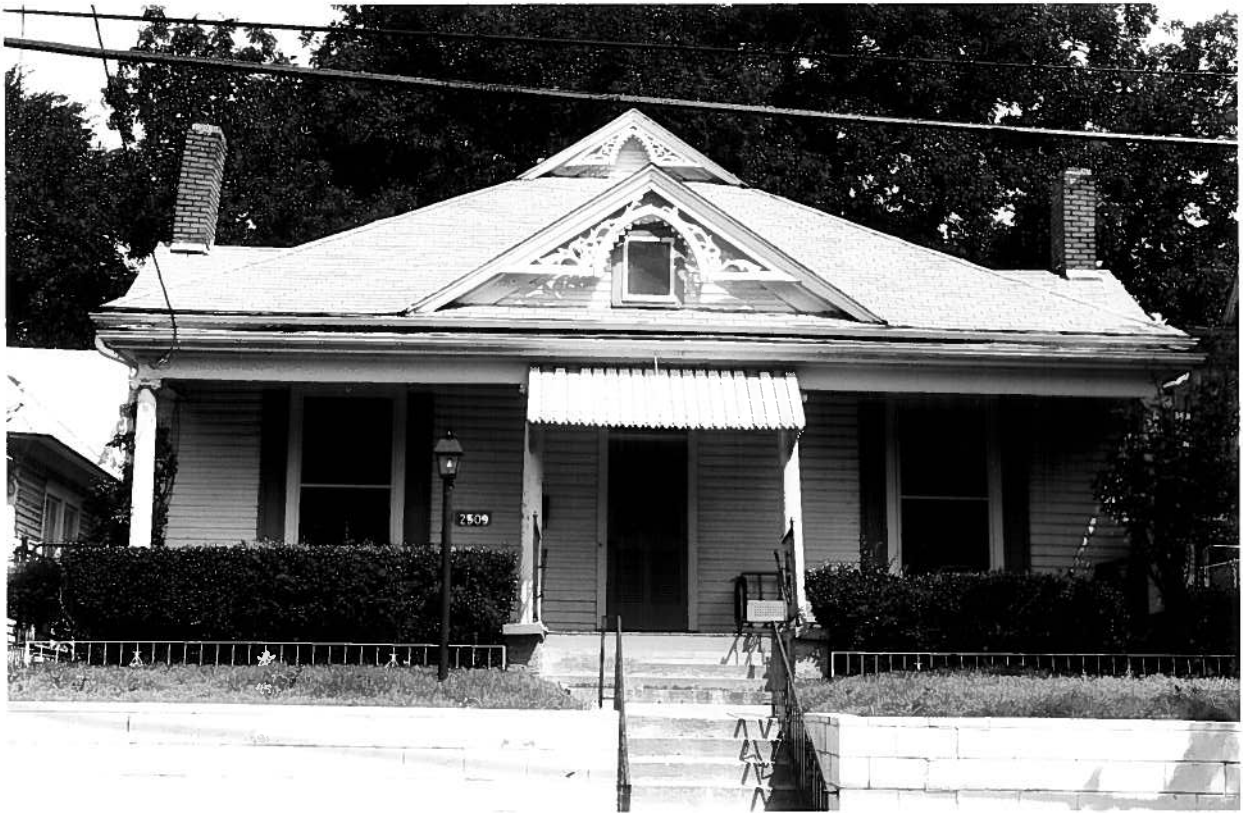
No. 14 - 2505 Thomas

Approx. 1895-05;

Description: Planbook, main hip roof with gablet, twin gable projections at sides, center gable pediment, twin side end chimneys, Ionic porch columns, trim scrolls in gable ends new, 1/1 windows.

Condition: Excellent.

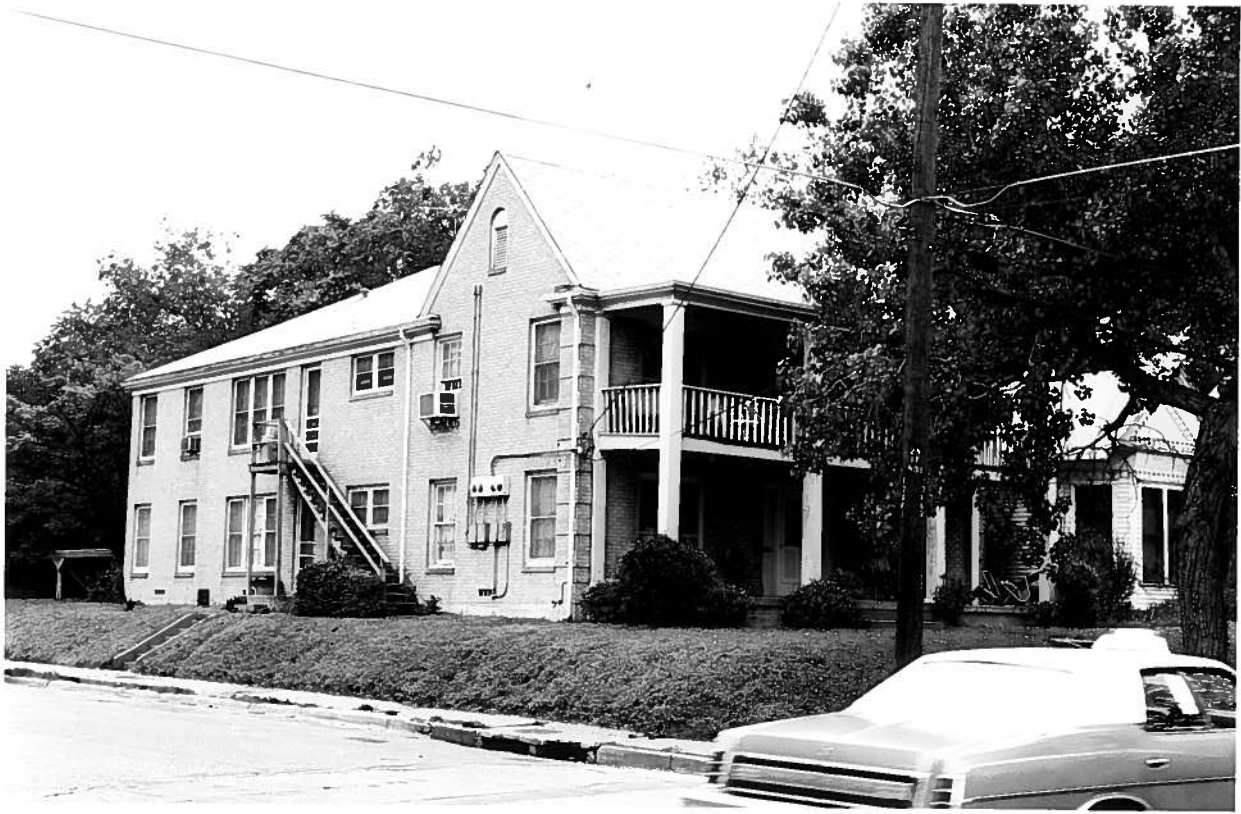
No. 15 - 2501-03 Thomas

Approx. 1920-30;

Description: 2 story, beige bricks, quoins, porch and balcony across front, heavy square porch columns, 6/6 windows, intersecting gable roof.

Condition: Good.

Significance: Probably none.

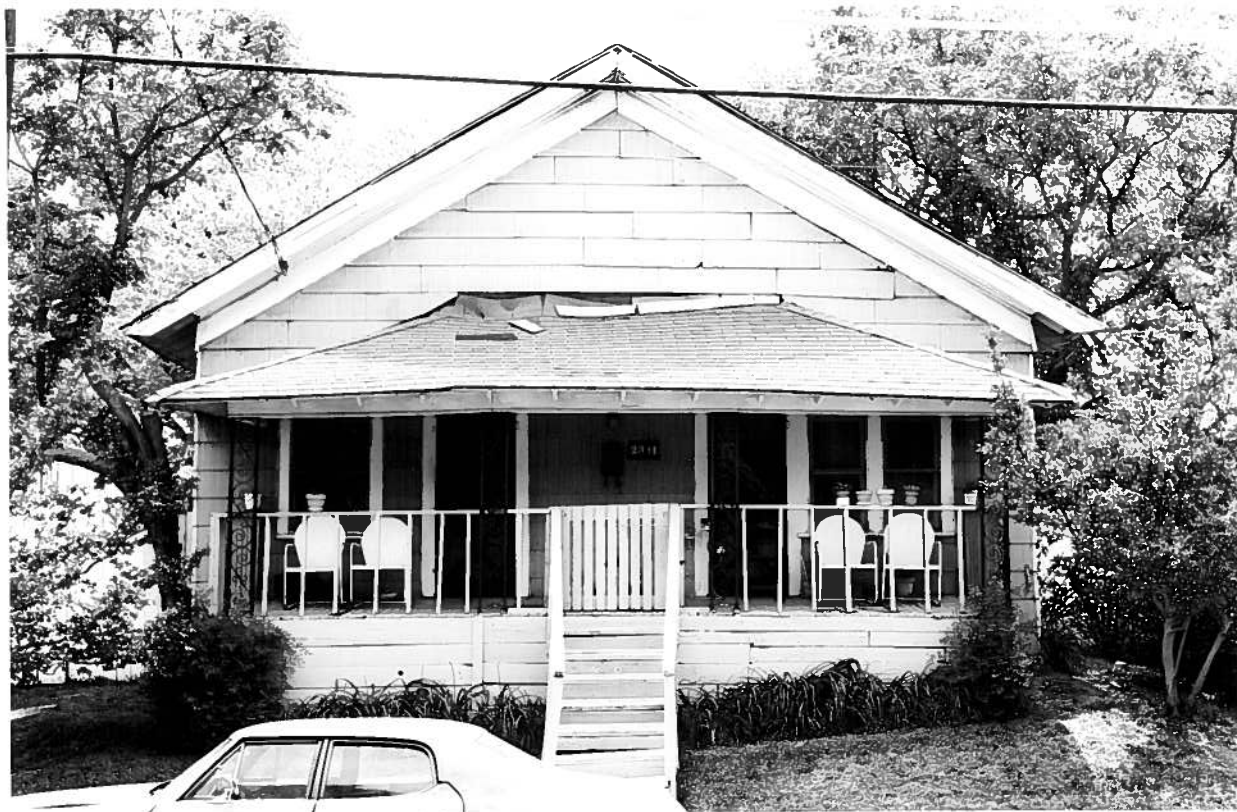
No. 16 - 2311 Routh

Approx. 1905-15;

Description: Planbook, gable roof with exposed rafter hip porch roof, elevated wood front porch, 2 front doors, 1/1 windows, wide trim boards.

Condition: Fair-covered.

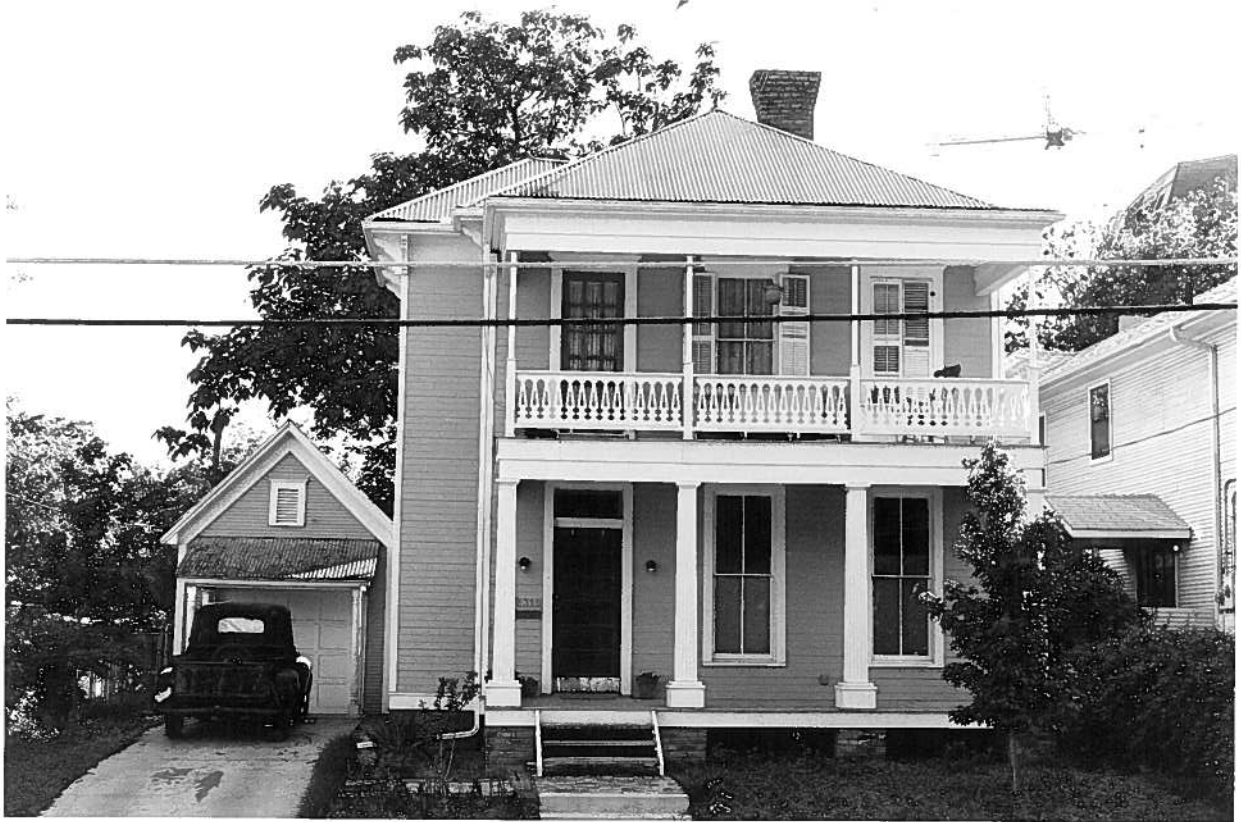
No. 17 - 2315 Routh

Approx. 1890-1900;

Description: Craftsman, 2 story, main steep hip roof, side pavilion with hip roof, large central chimney, porches for both stories, 2/2 tall narrow windows, boxed extended eaves, deep trimmed cornice, transom.

Condition: Excellent - restored.

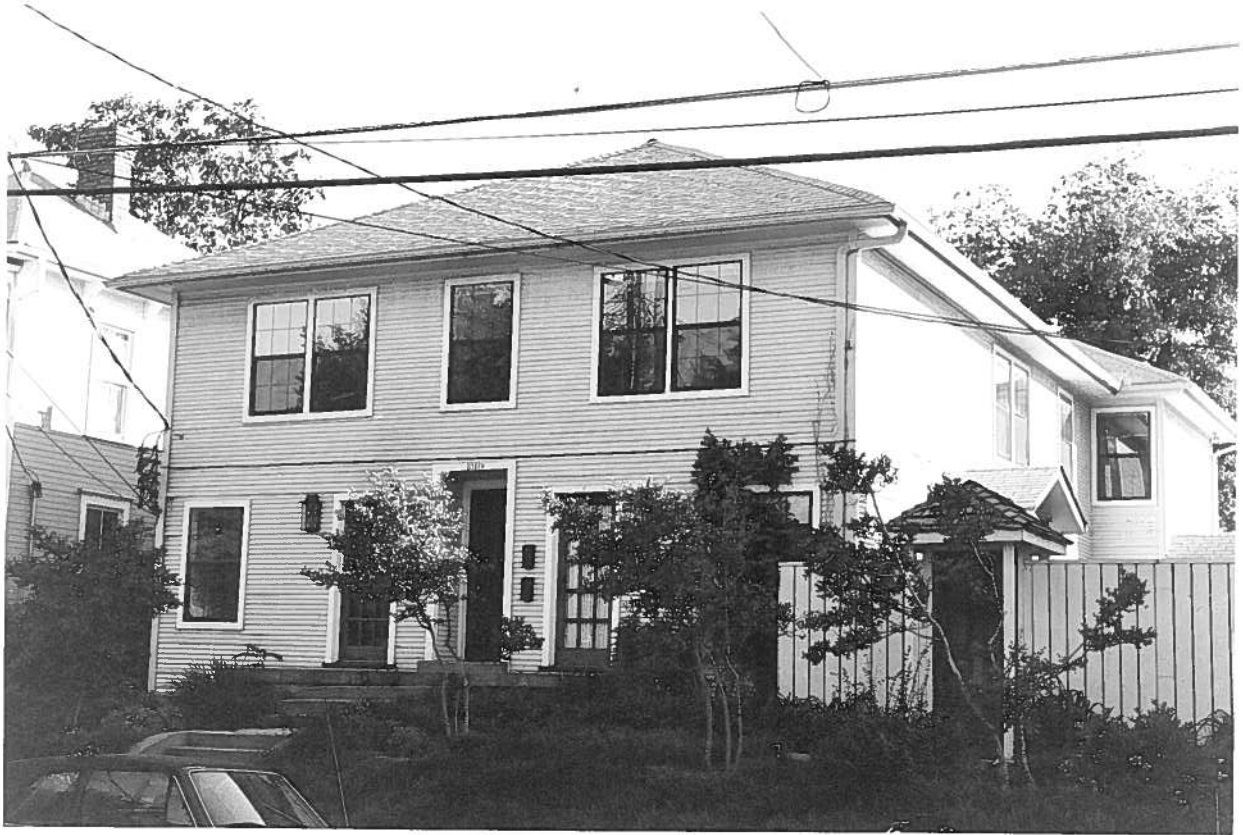
No. 18 - 2317 Routh

Approx. 1910-20;

Description: 2 story, hip roof, 6/6 windows,
15 light front doors, boxed extended eaves,
narrow lap siding, narrow board trim.

Condition: Excellent - restored.

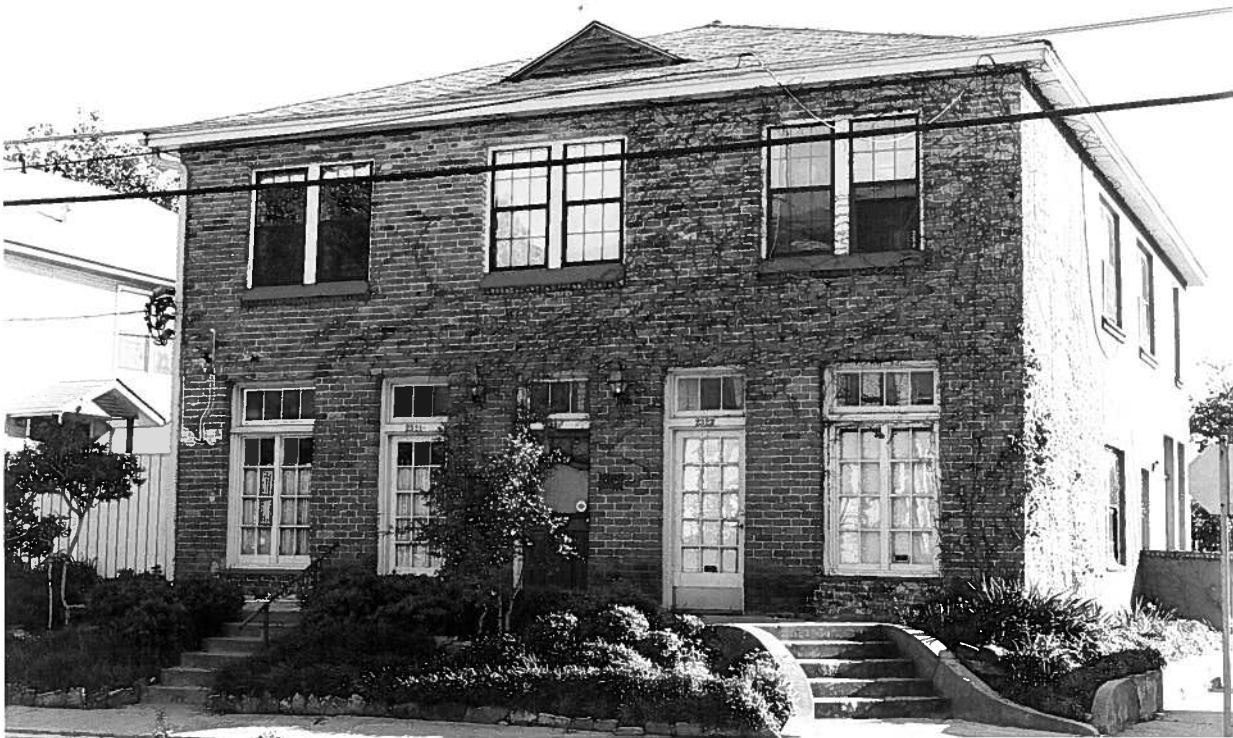
No. 19 - 2321 Routh

Approx. 1915-25;

Description: Shallow pyramid roof, 2 story, 6/6 second floor windows, paired 8 pane windows with 4 pane transom, 2-15 light doors with 3 pane transom, center door with 3 pane transom, medium red brick.

Condition: Excellent - restored.

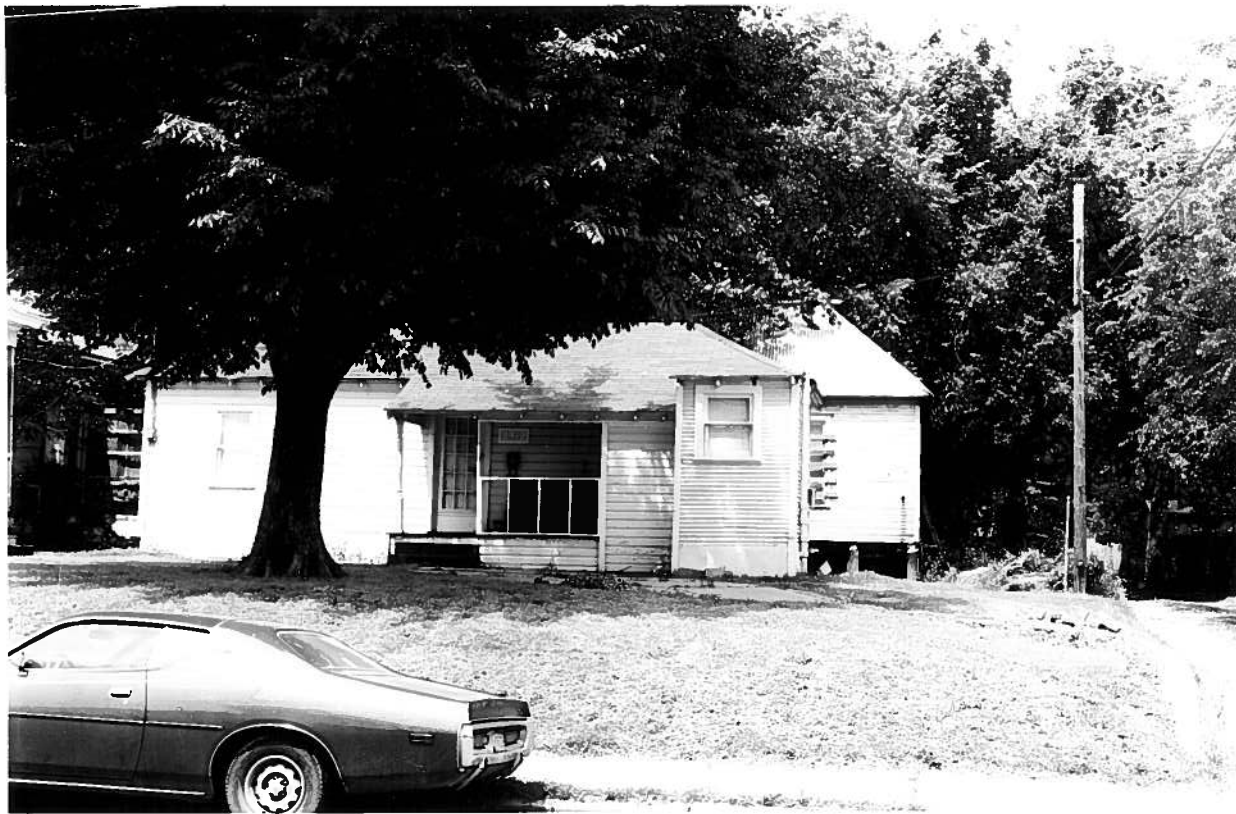
No. 20 - 2312 Routh

Approx. 1910-20

Description: Planbook, main hip roof with exposed rafters, elevated on piers, wide and narrow lap siding, front porch partially enclosed, turned porch posts.

Condition: Excellent.
